Recognition of current status on the Access Roads to “El Tesoro” Project Report.

July 22nd, 2002

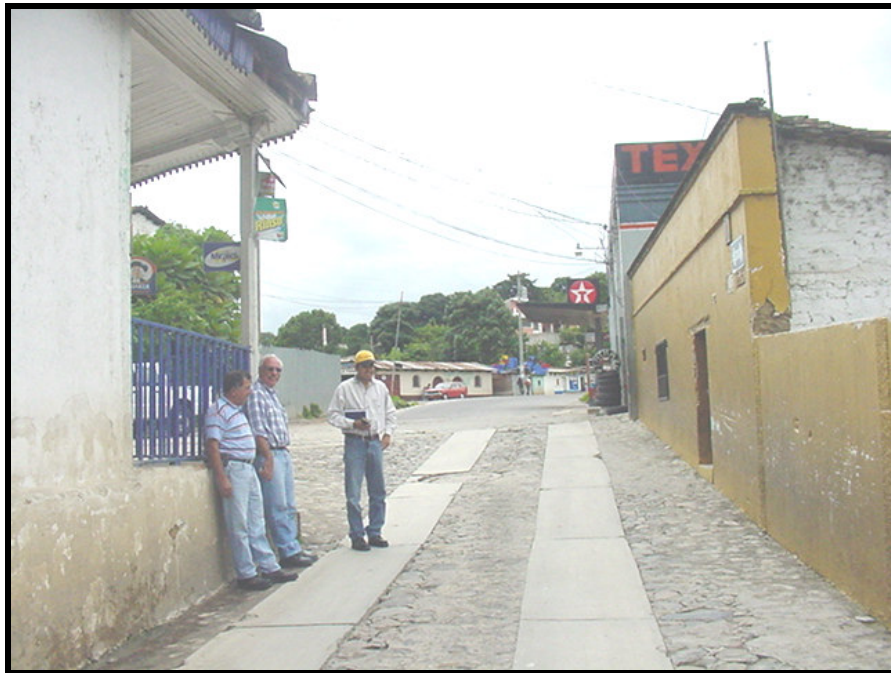
Picture No. 1

This picture shows the narrow of the street (4.00 m) and the low of the roof (4.00m) which can be a problem when transporting equipment. It can be solved with shorter transport.

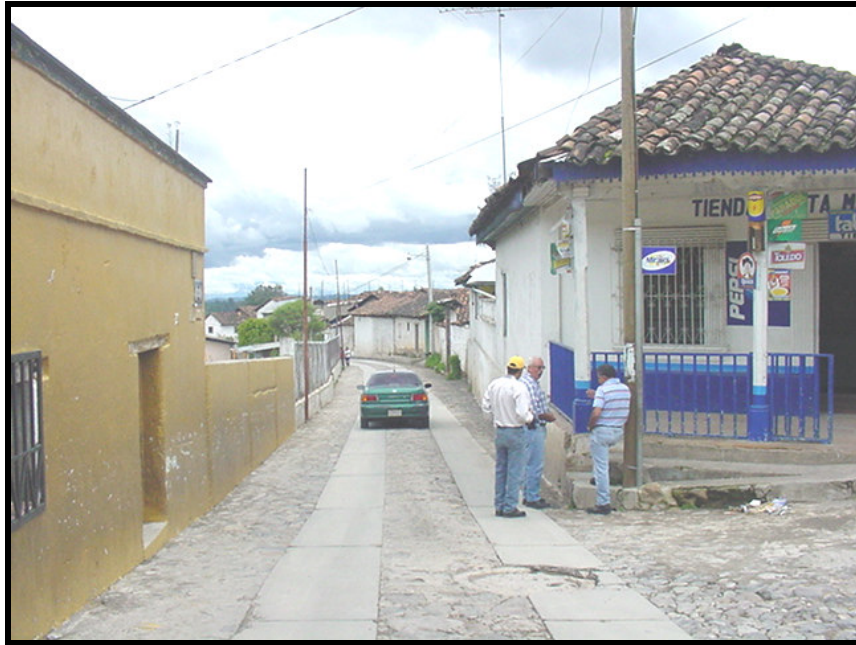
Picture No. 2

Opposite site from picture 1, it can be seen the narrow of the street taking the car on it as reference.

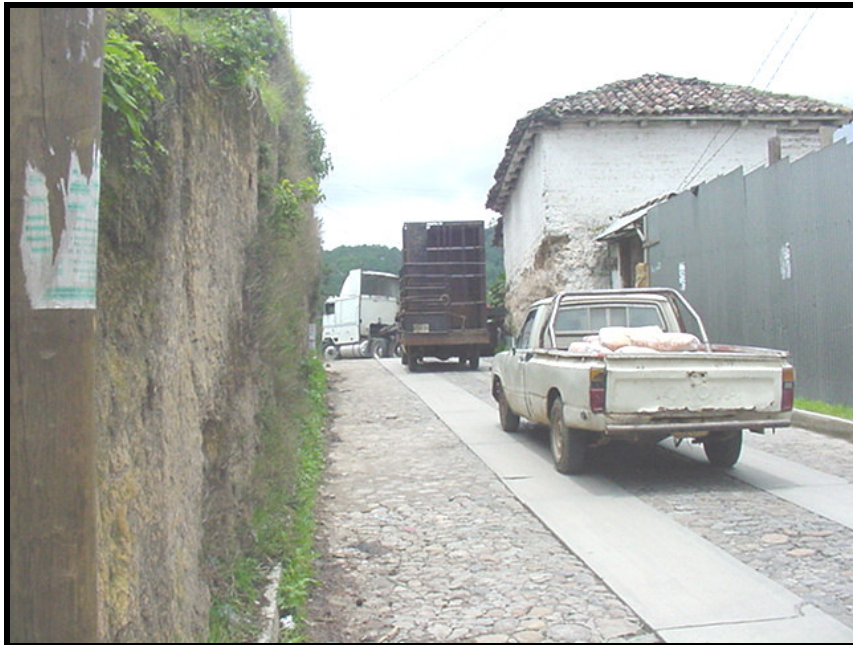
Picture No. 3

The 40 feet platform in the picture is having problems, with the white house, to turn in the corner.

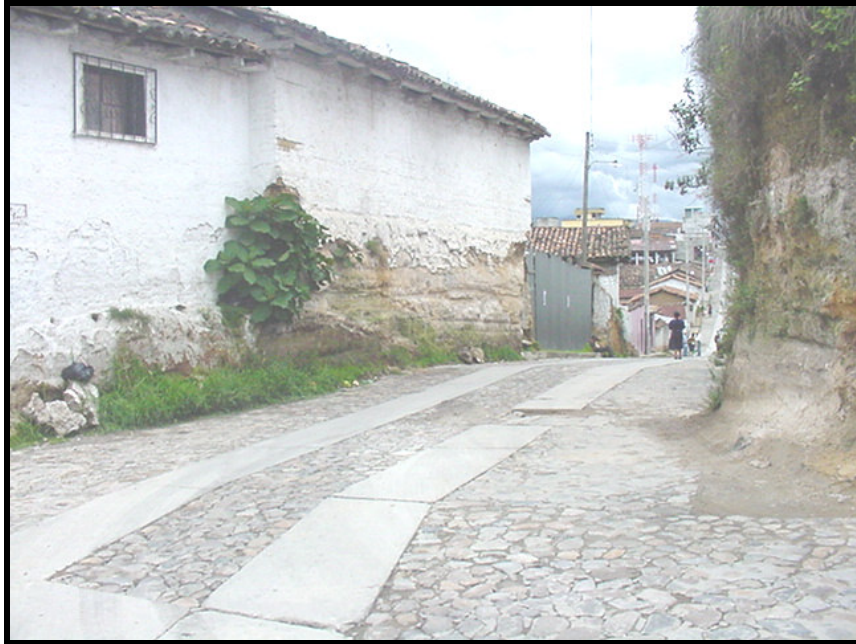
Picture No. 4

Same corner described on picture 3 see from a different angle. It can be seen the damage vehicles had caused to the white house when they turn.

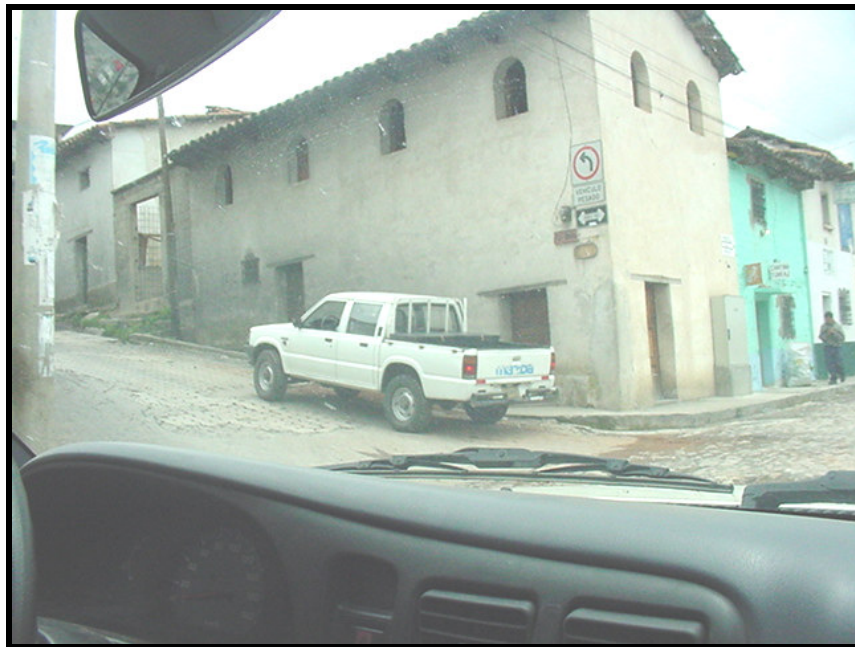
Picture No. 5

Corner in front of Hotel Santo Tomás (Chichicastenango's downtown) there is not possible to turn with equipment with a width larger than 3.00 meters.

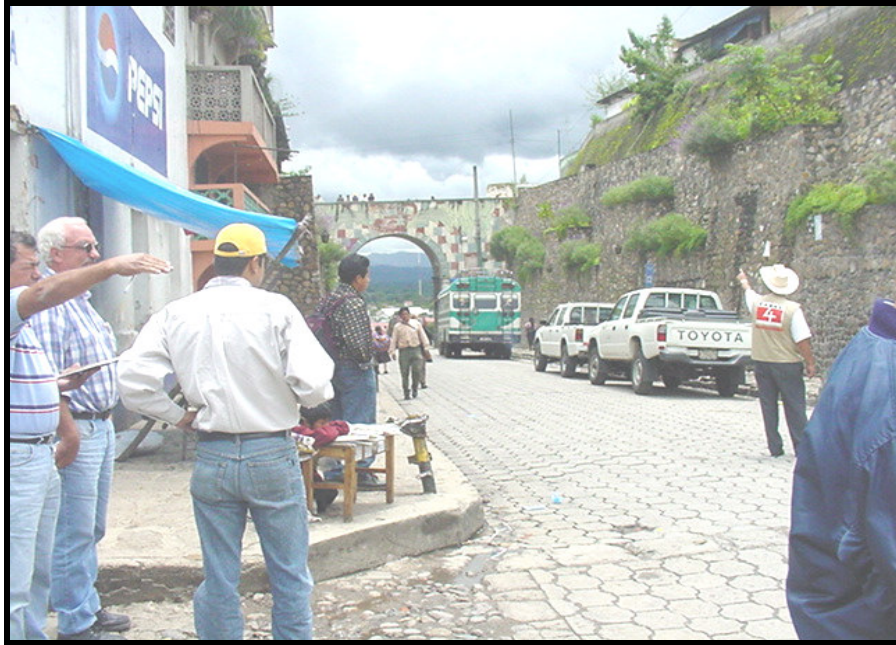
Picture No. 6

This is the last difficult turn on Chichicastenango's exit.

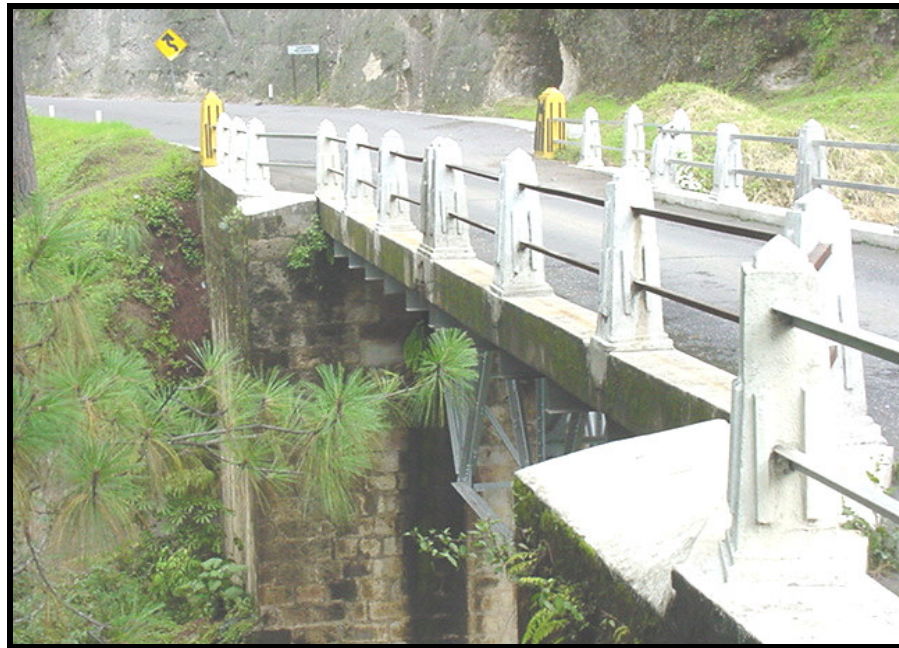
Picture No. 7

Bridge between Chichicastenango and Santa Cruz del Quiché, which does not have enough reinforcement to resist the weight of the heaviest equipments plus the transport weight, but it can be solved by using long platforms so the weight is not concentrated (2 shafts).

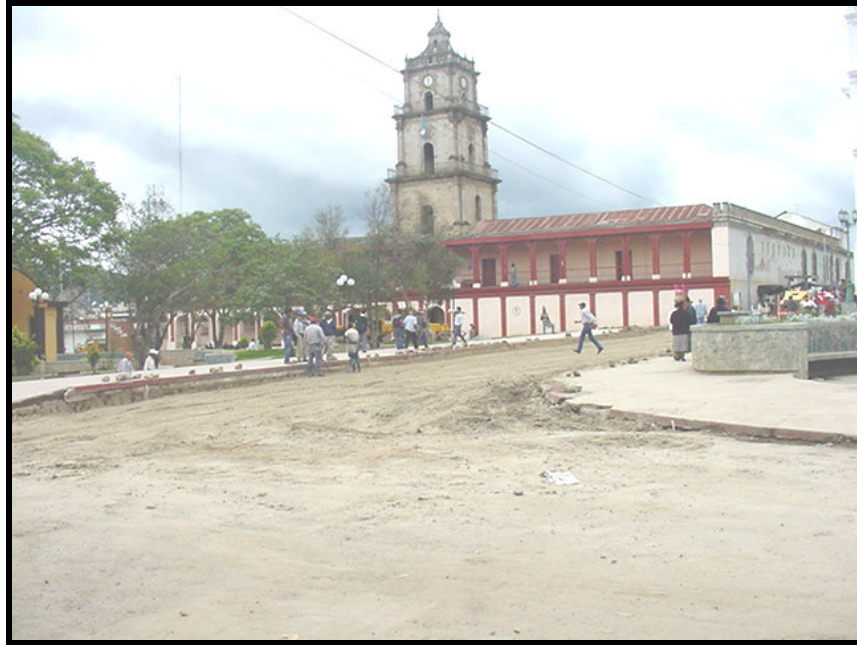
Picture No. 8

There are no main problems on turning in Santa Cruz del Quiché.

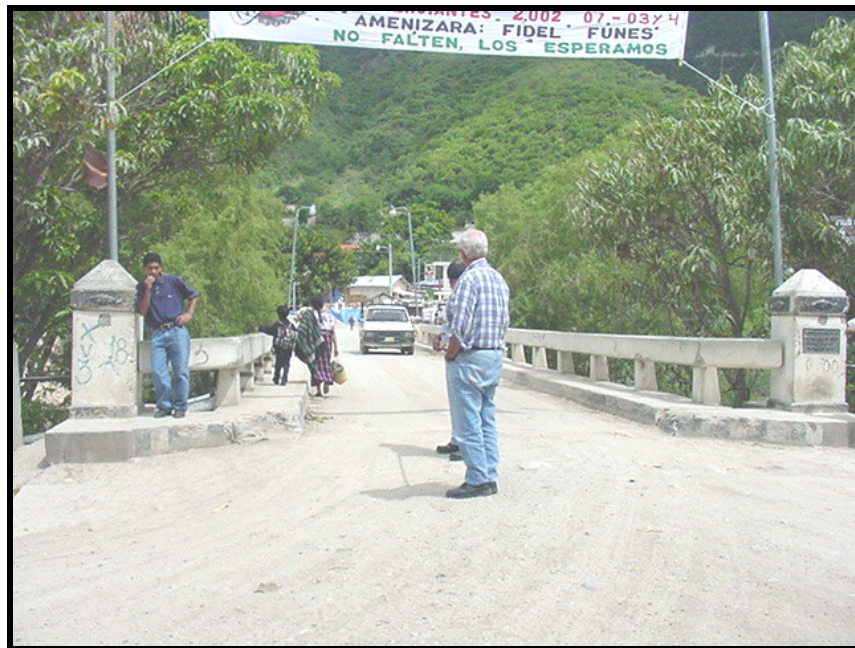
Picture No. 9

Exit to Sacapulas, the perpendicular street to the central line of the cross sectional line for the bridge is too narrow, consequently it is not possible to turn with a long platform because the street is under filler; it can be solved by extending the stuffed.

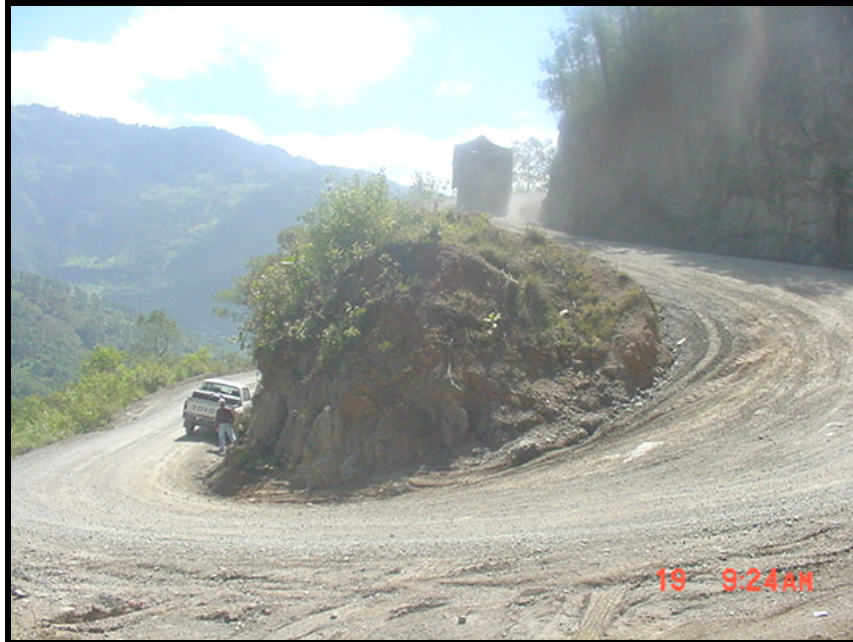
Picture No. 10

There are approximately 6 sections like this where it is very difficult to transit with heavy equipment, reason why it is necessary to extend the width of the curve from the outside. Also due to the steep slopes it was suggested to use a frontal shipper, for example to push the transport of the equipment where necessary, this picture taken in kilometer 4 after Sacapulas and before arriving to Nebaj.

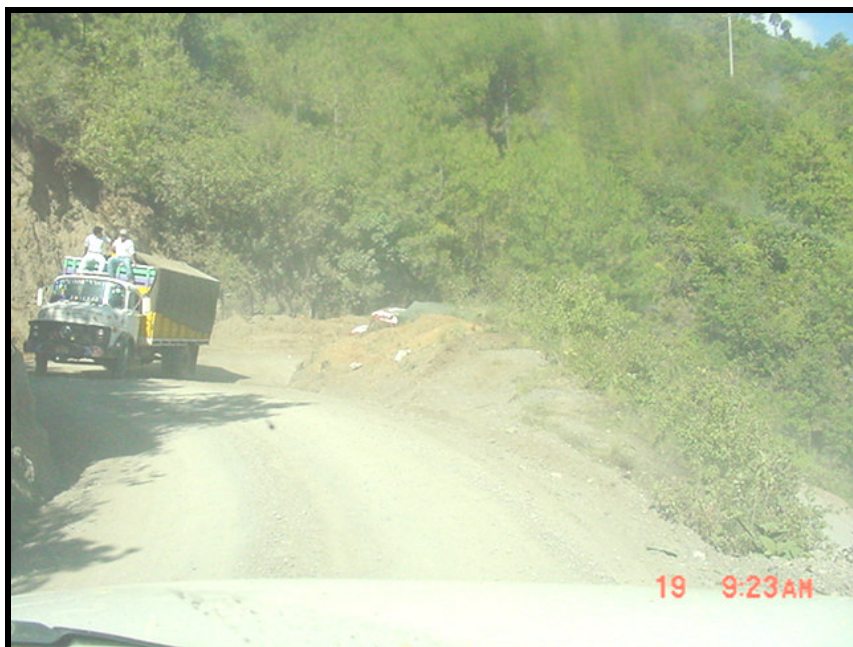
Picture No. 11

Picture taken from the front of the truck of picture 10, the narrow curve can be observed.

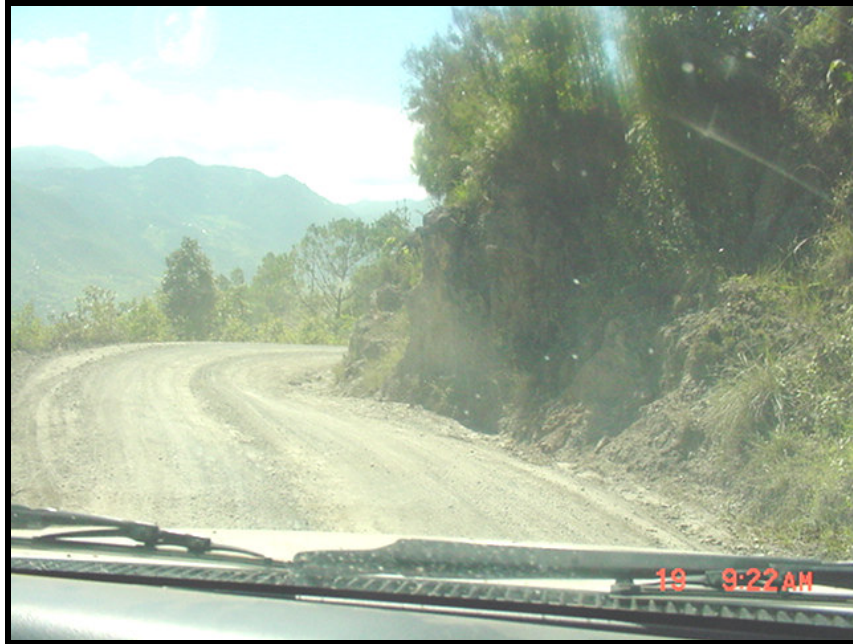
Picture No. 12

Cuts on slopes will be needed in order to help platforms to turn.

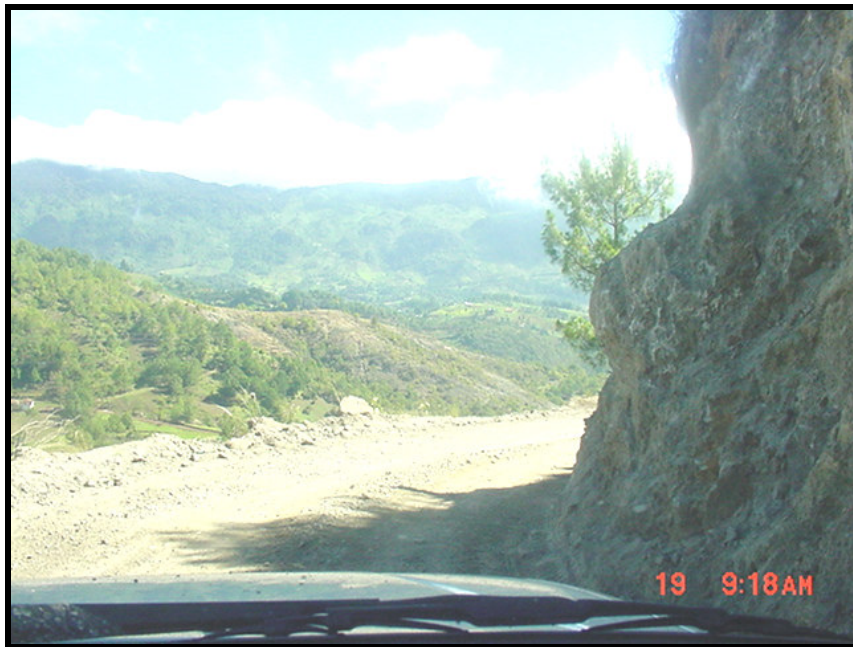
Picture No. 13

There are some stone cuts, which make necessary to determine whether to use explosives or not in such areas. Pictures (12 and 13) were taken on kilometer 8, From Sacapulas to Nebaj.

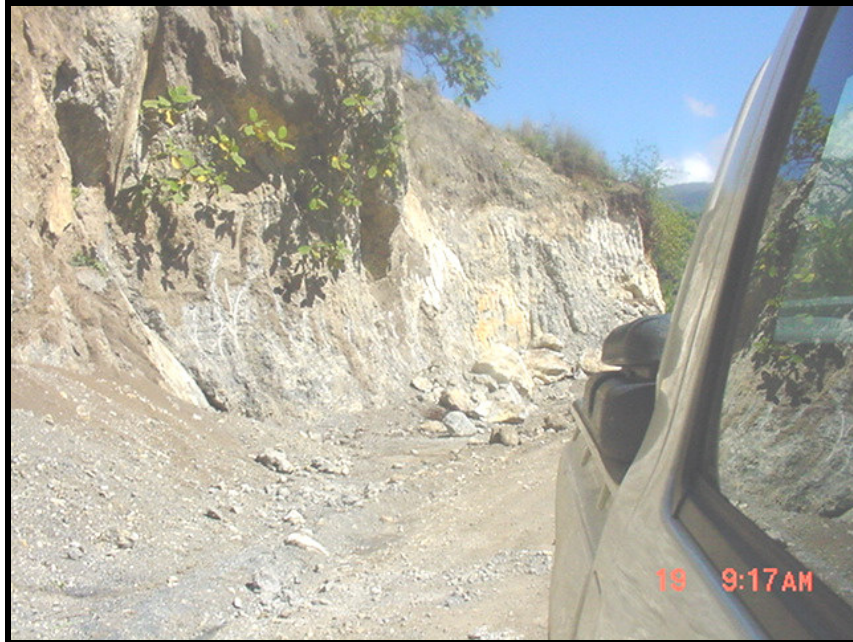
Picture No. 14

According to Luis Verdugo Repetto, S.A. and Soluziona Ingeniería, there are some areas where material can be extracted. Kilometer 12 from Sacapulas to Nebaj.

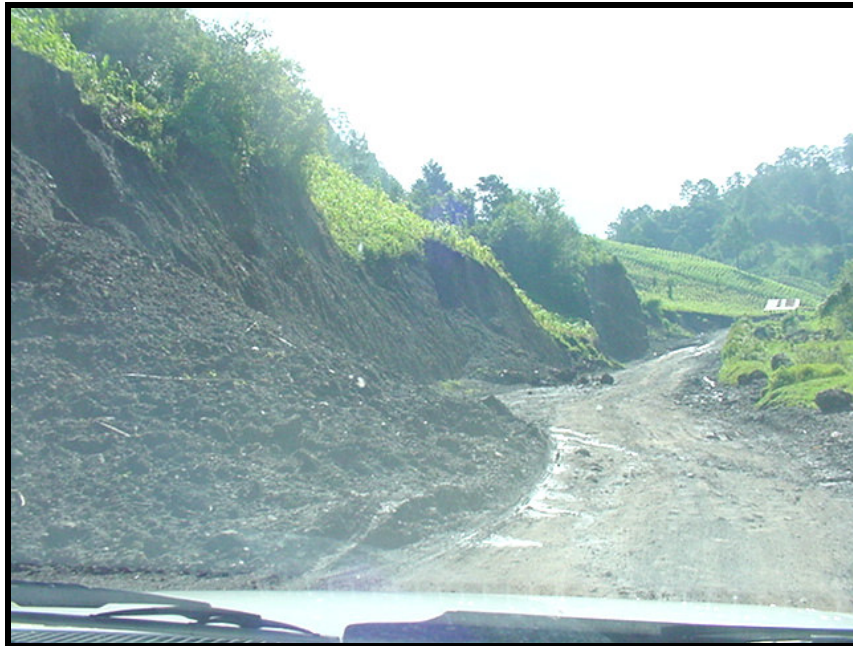
Picture No. 16

Between Nebaj and Chajul there are some sections with slides due to the lack of slopes protection. Up to present the road construction works are in hold.

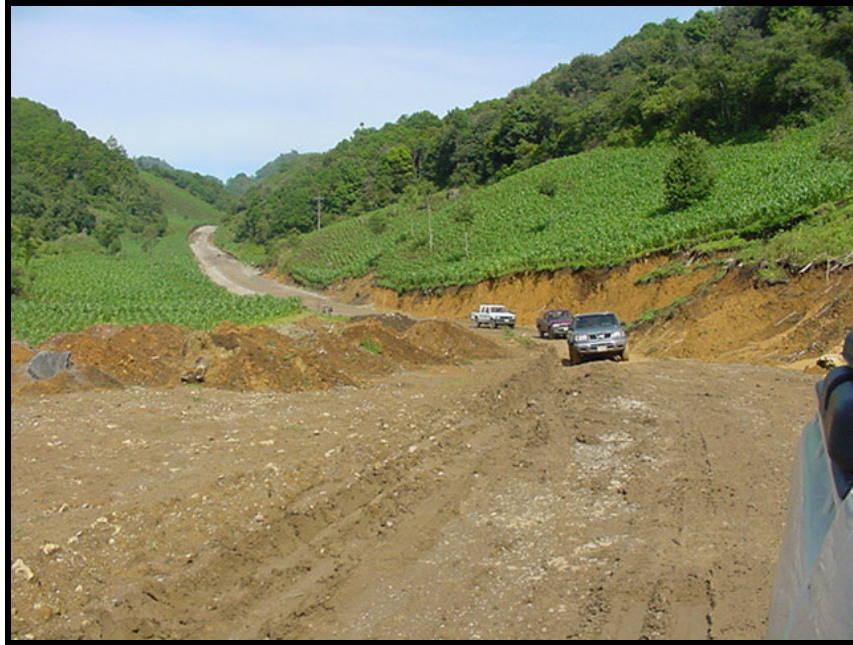
Picture No. 17

There are some clay sections which turn difficult to drive through, especially for rainy season. On the right side of this picture, slides on the slope can be found.

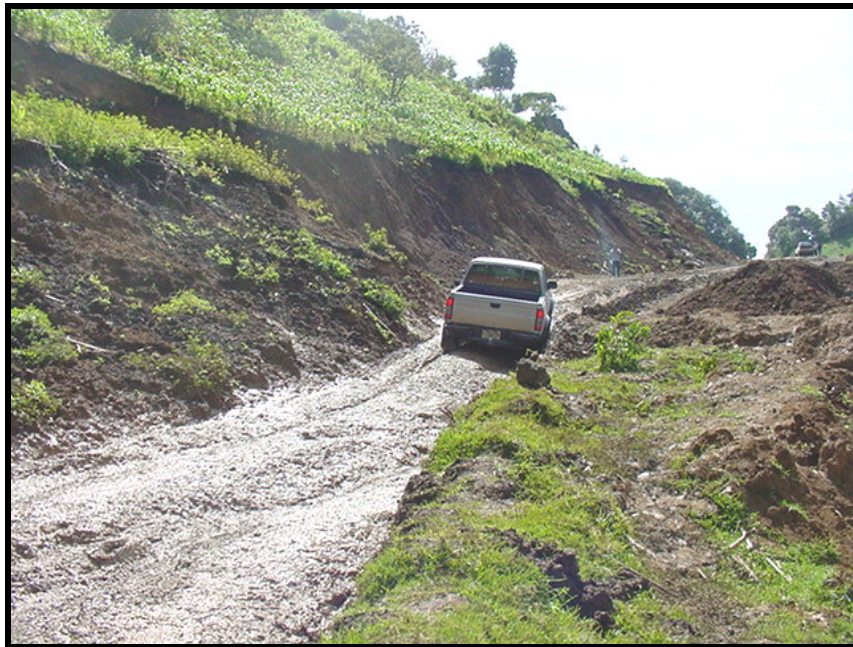
Picture No. 18

Because of the lack of slopes protection and roadside ditches, the soil gets saturated causing slides which sometimes makes necessary to close the road. See the slide on the left side.

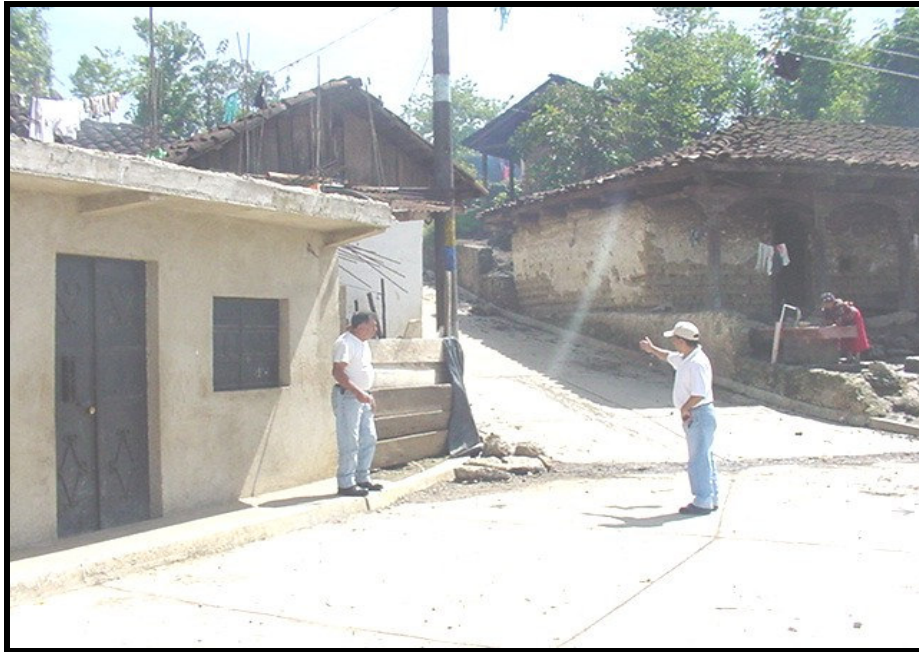
Picture No. 19

Chajul's downtown has 4 places like the one in the picture, where there are turning problems because of the houses and the narrow street. It is a must to negotiate with owners in order to extend the it.

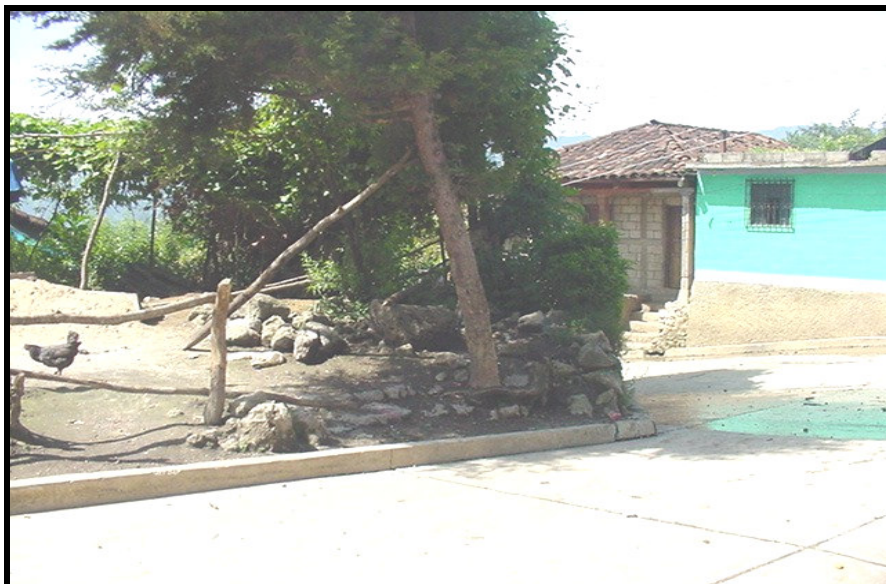
Picture No. 20

Another difficult corner to turn in Chajul.

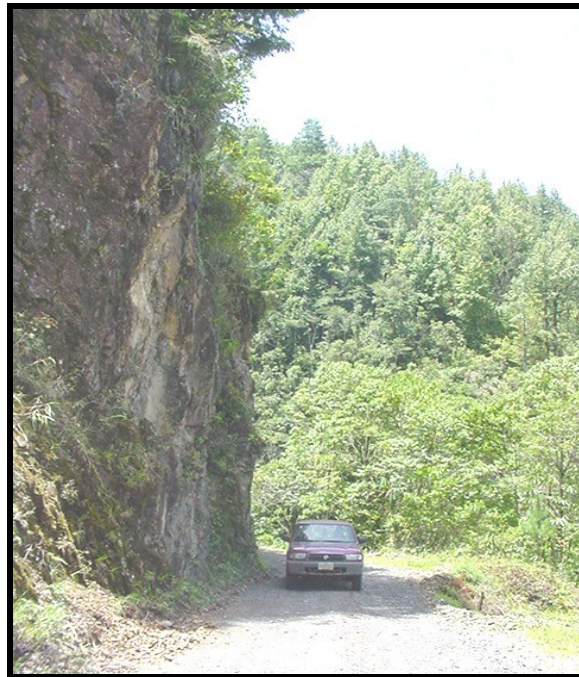
Picture No. 22

Stone cuts must be done in many sections in order to help big vehicles to turn.

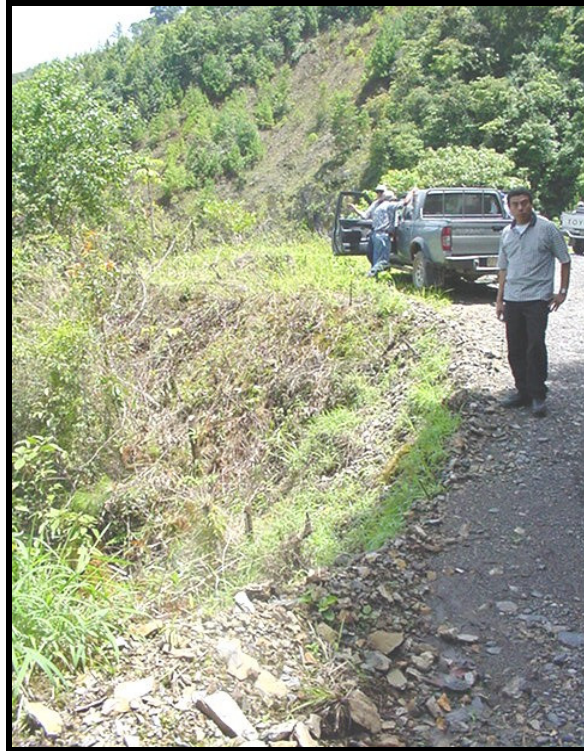
Foto No. 23

A retention wall must be build in areas like the one describe on picture 23 due to the narrow of the road.

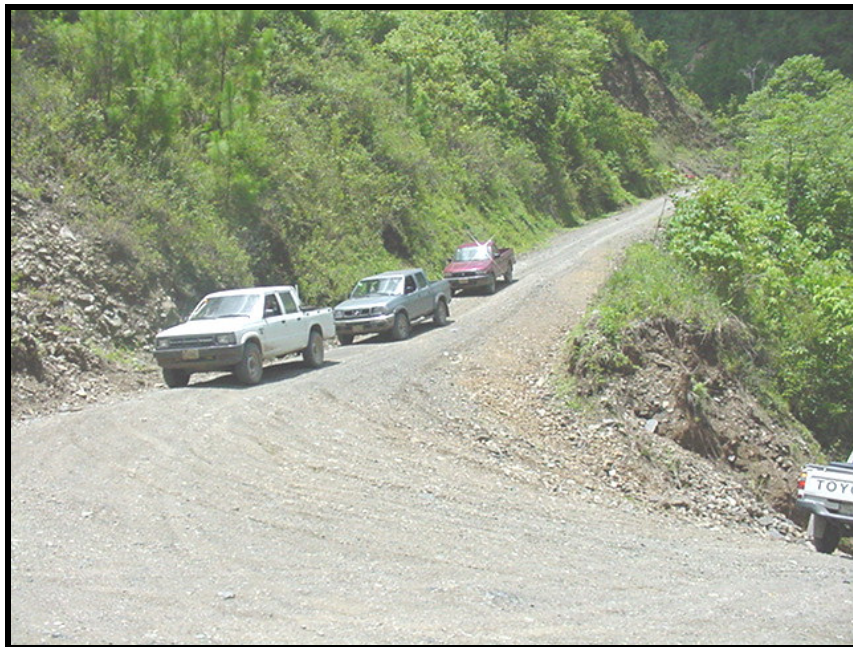
Foto No. 24

This is one of the most difficult curves, because it has a very steep slope.

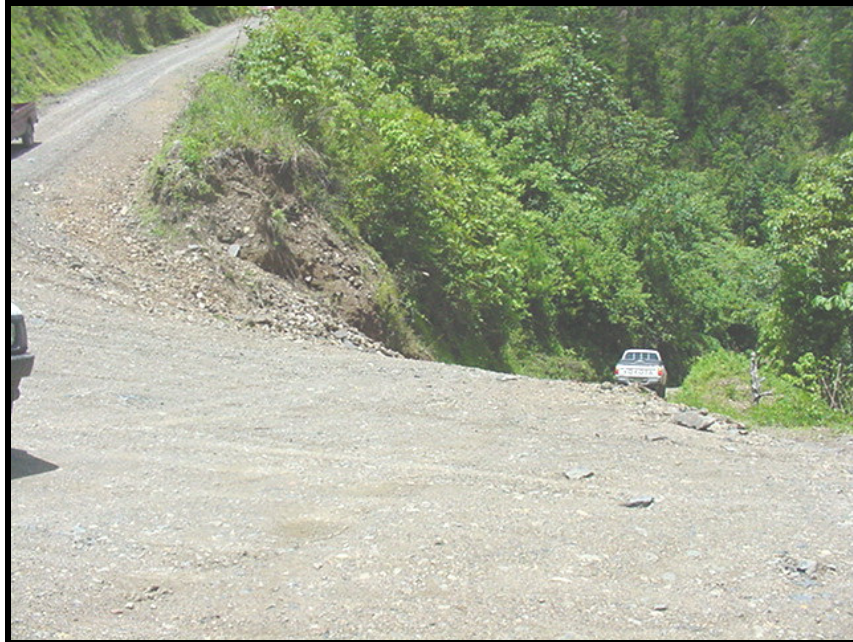
Picture No. 25

Complement of picture No. 24. All vehicles must go back in order to take the curve.

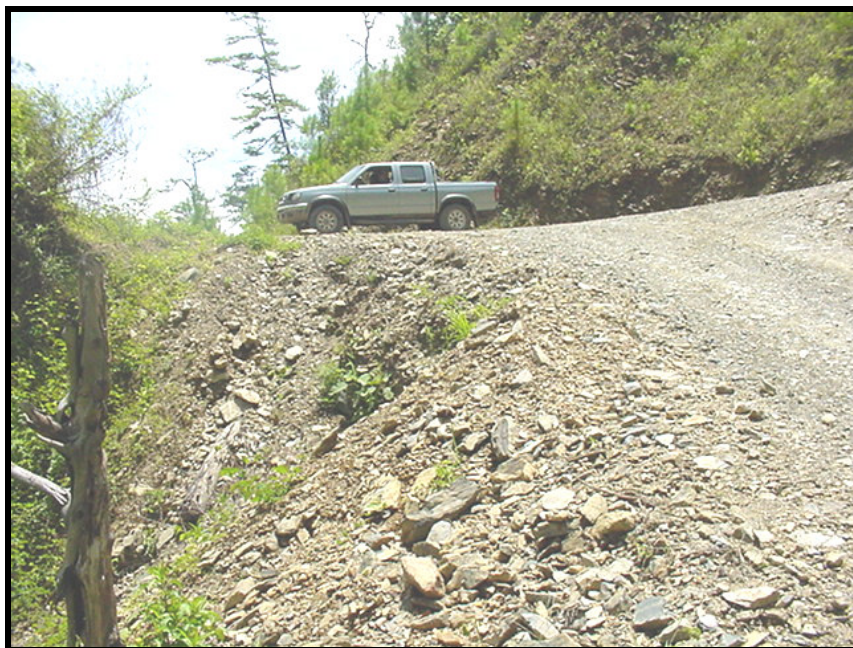
Picture No. 26

Same curve as in pictures No. 24 and 25. It is not possible to extend the curve on its outside side because the precipice, so Repetto, S.A., said they can supply the transport equipment up to kilometer 22 from Chajul.

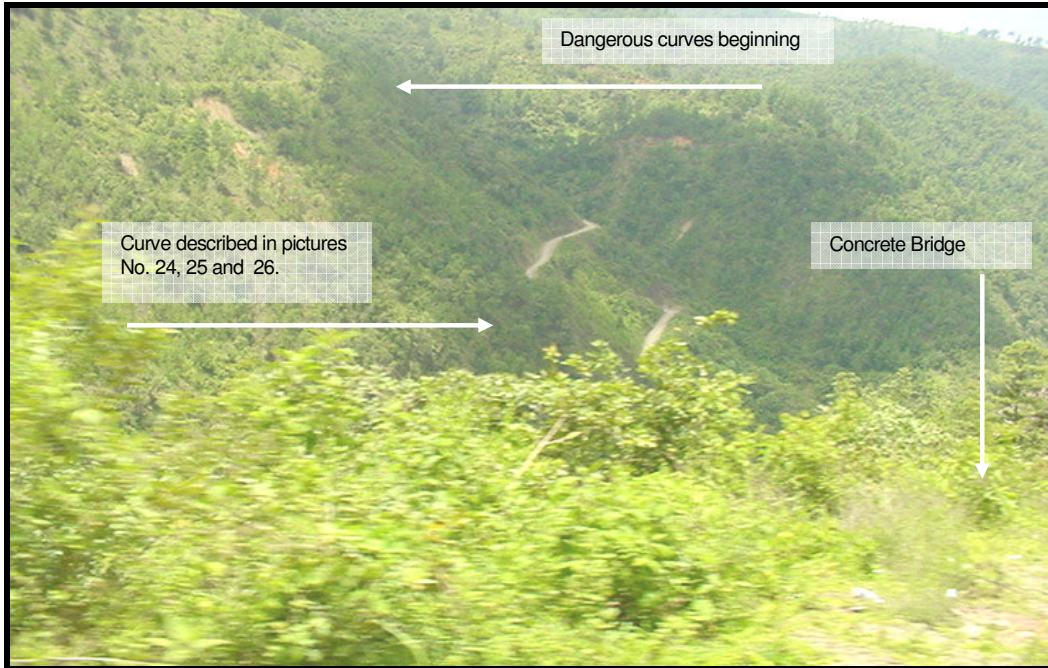
Picture No. 27

In this picture it is showed the most critical section for the equipment transportation. On sections described on pictures 24, 25 and 26 is not possible to extend the curve on the outside side because there is a gully and on the inside side neither because that would make a very steep slope.

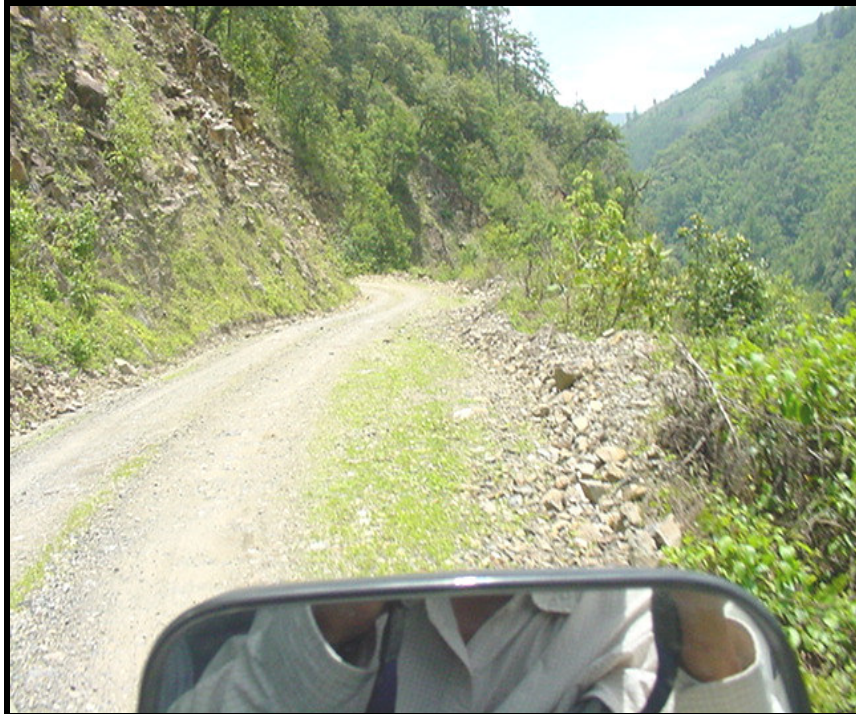
Picture No. 29

Narrow of the road (1 way)

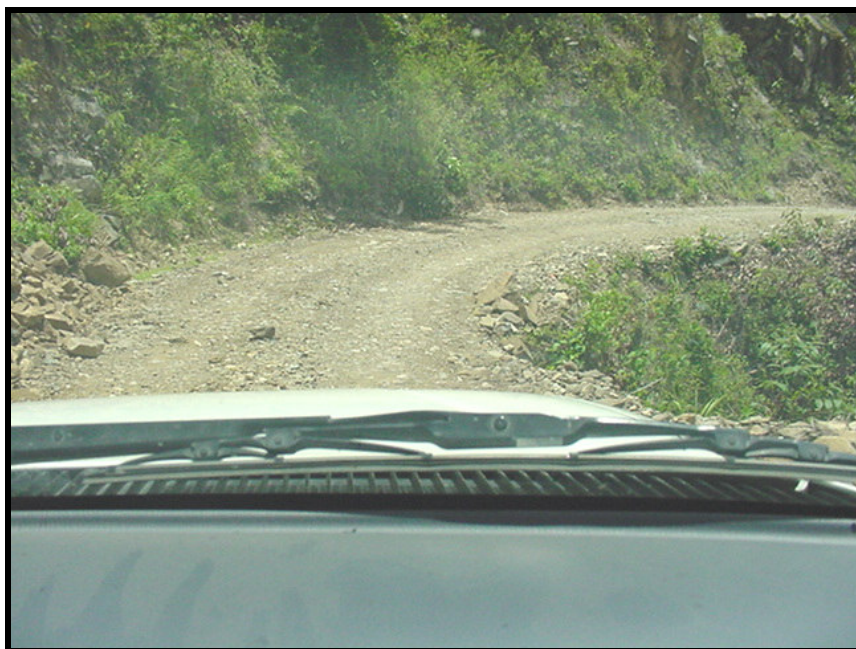
Picture No. 30

The narrow curve makes difficult to turn, that is why is it's a need to cut the outside side of the curve. The curve cannot be filled because the gully is too big.

On the right side of this picture the narrow curve described on picture No. 30 can be observed. It is not possible to fill the gully; the slop must be cut. It is dangerous to work in that section.

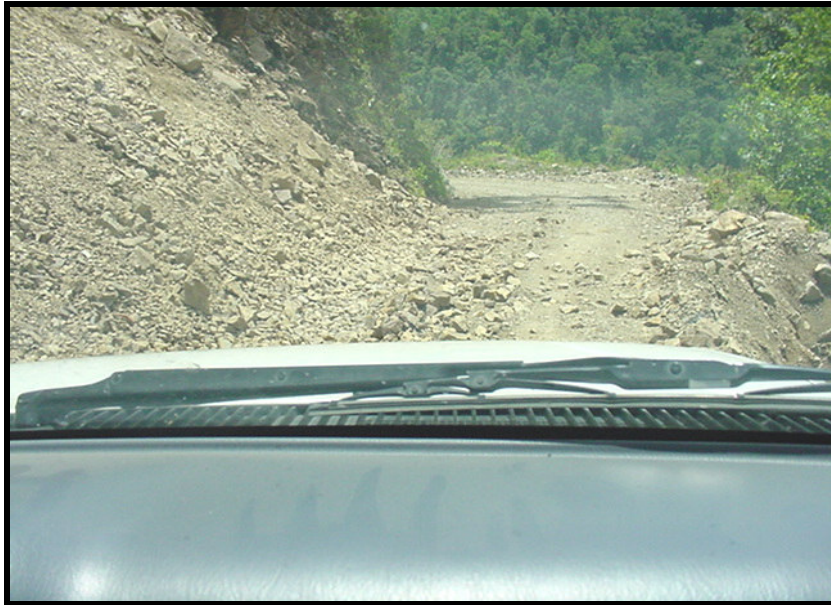
Picture No. 31

The landslides make difficult to drive through the road. This section is between the concrete bridge and La Perla.

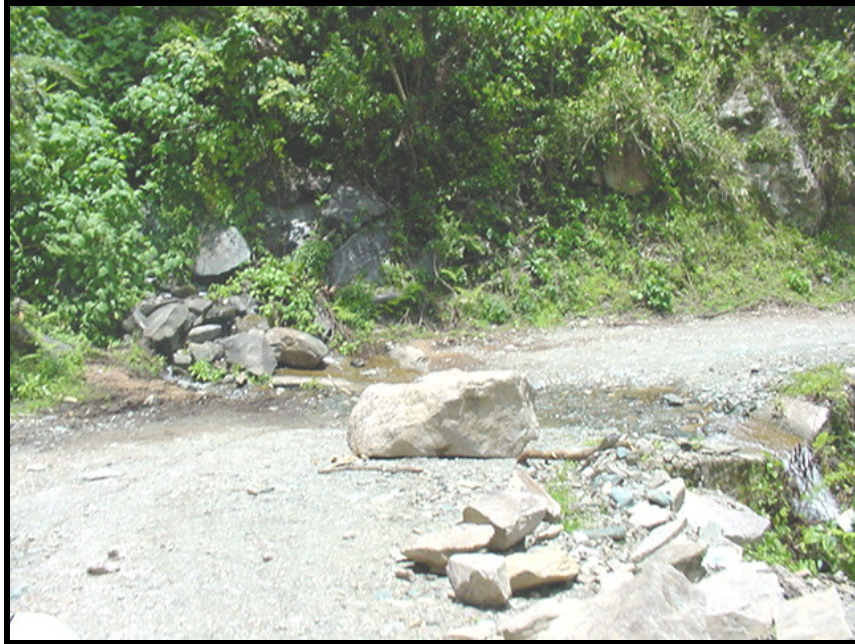
Picture No. 33

It is frequently to find landslide along the road.

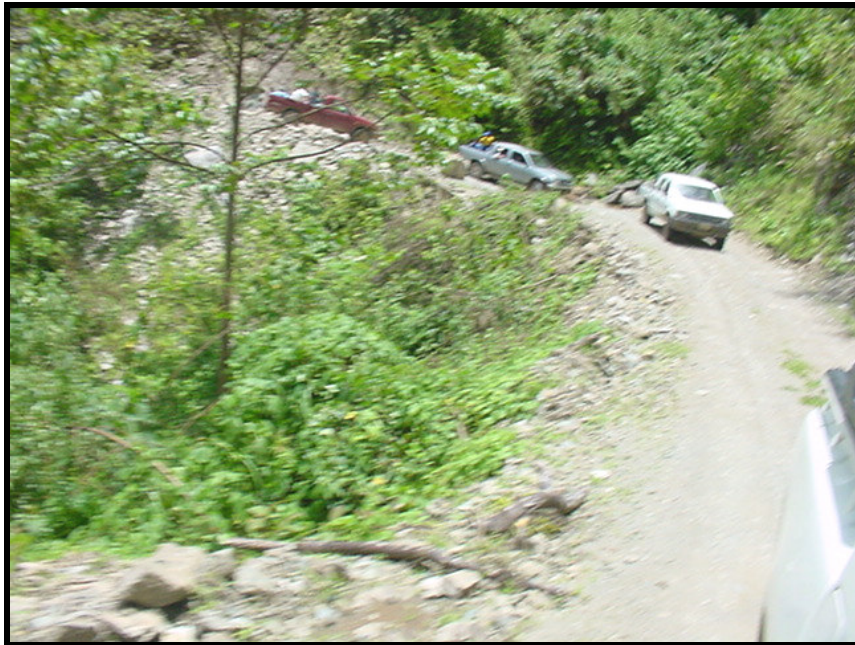
Picture No. 34

Long platforms cannot drive through this road, just small vehicles.

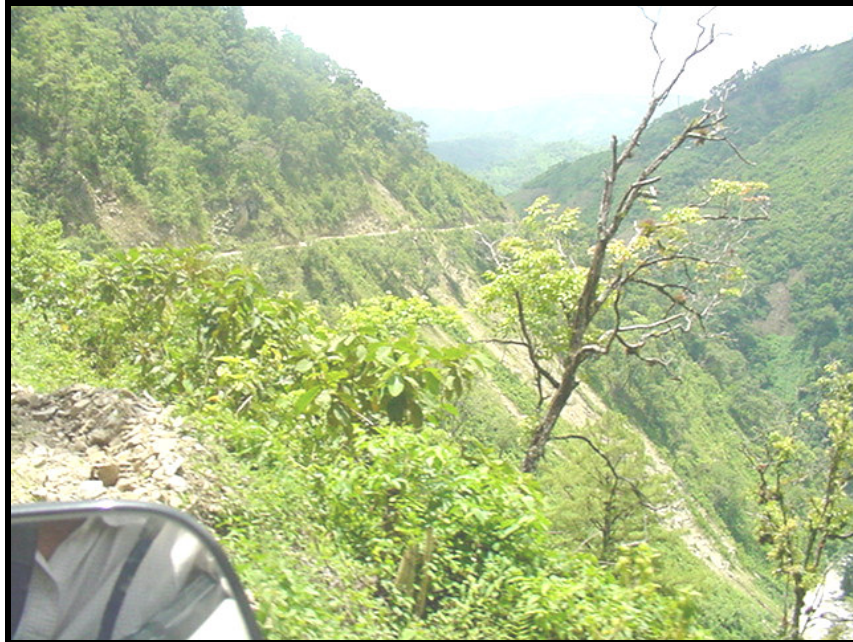
Picture No. 35

From the concrete bridge to La Perla, the road is dangerous.

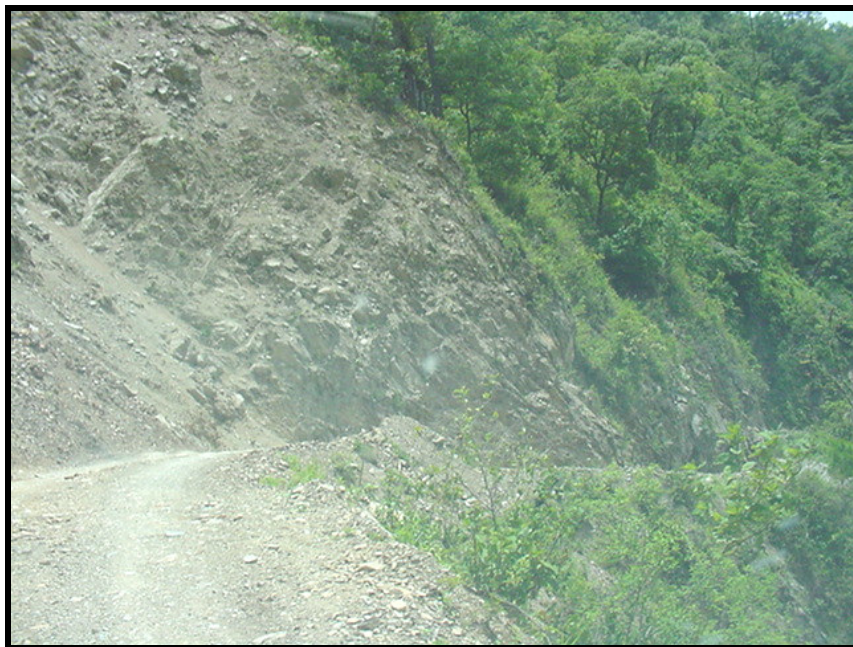
Picture No. 36

This is a landslide 4 kilometers before La Perla, and it is needed to have constant fixing Works.

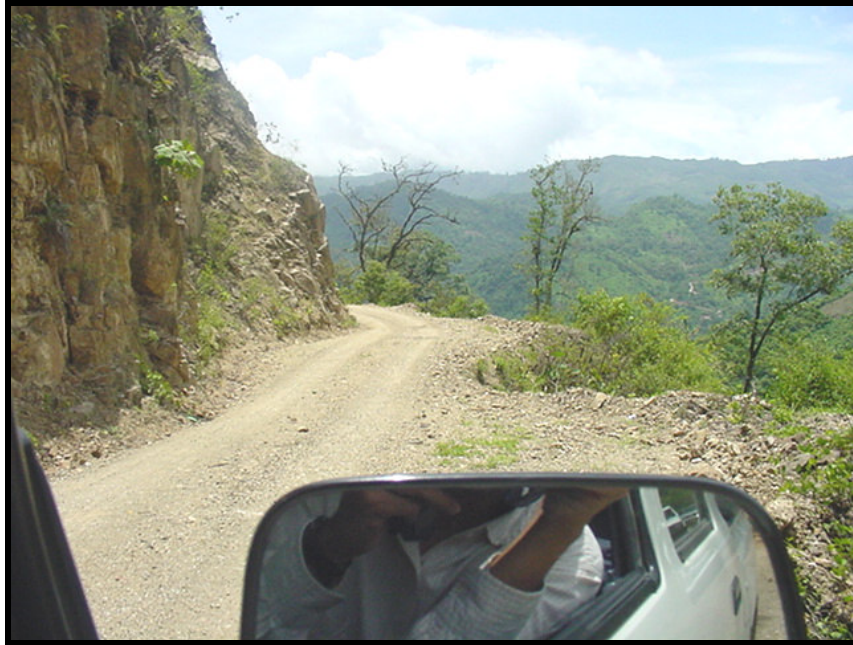
Picture No. 37

The road is full of gullies and narrow, which makes it dangerous especially with landslides, see right shore.

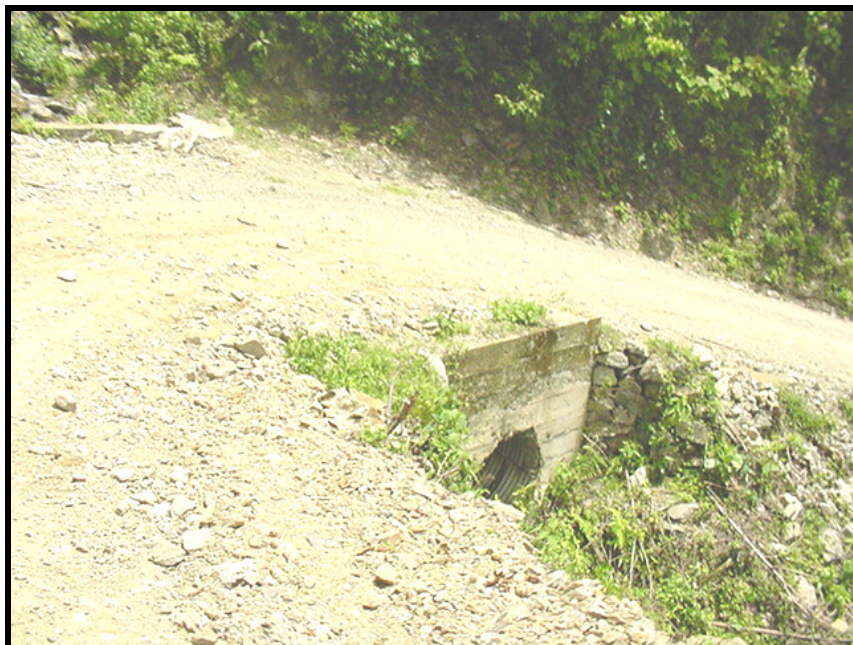
Picture No. 38

The narrow curve situation can be fixed filling the inside side of the curve in order to have space to turn.

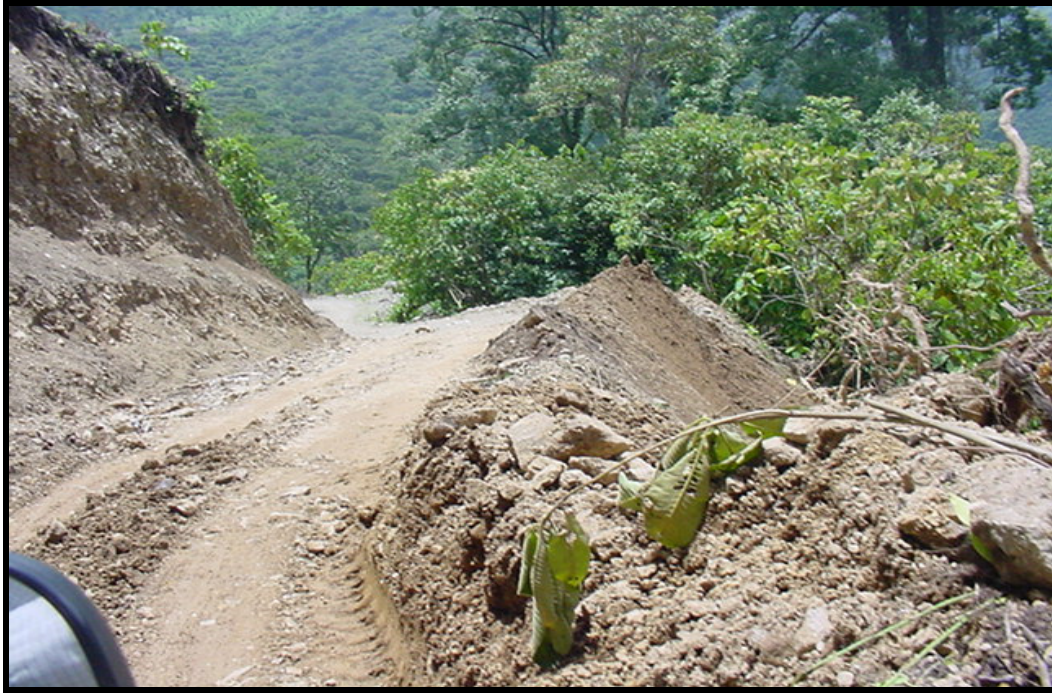
Picture No. 39

2.5 kilometers before La Perla. The constant rains caused a big landslide.

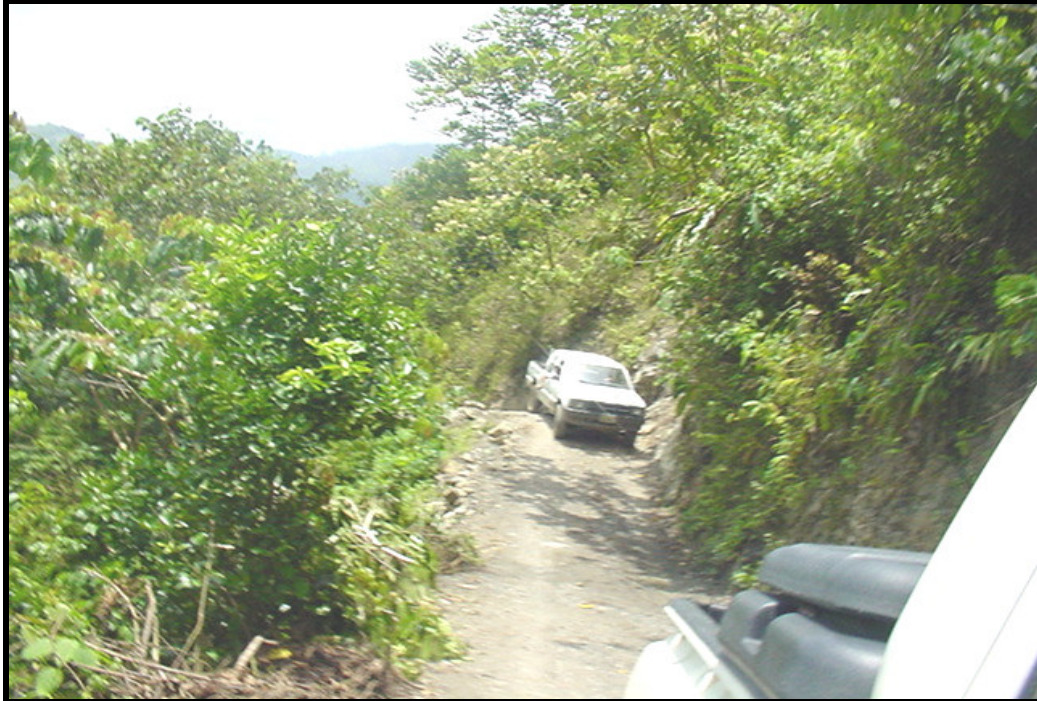
Picture No. 40

2 kilometers before La Perla, there is land bump, which would block the movement for long transportations. It must be cut.

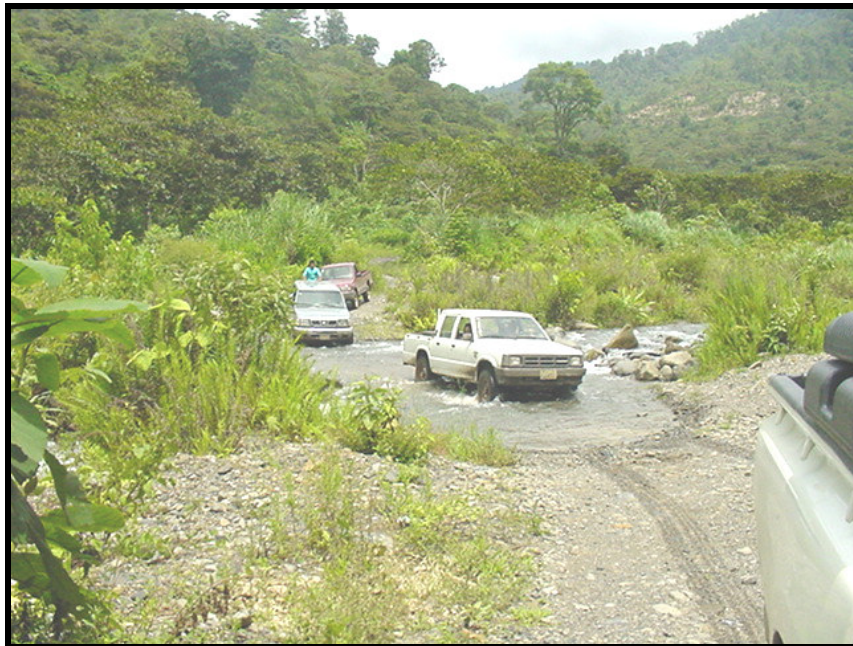
Picture No. 42

Ixtupil River (first entrance) where a bridge will be built in order to ease the access and it will be extended to prevent flooding on rainy season.

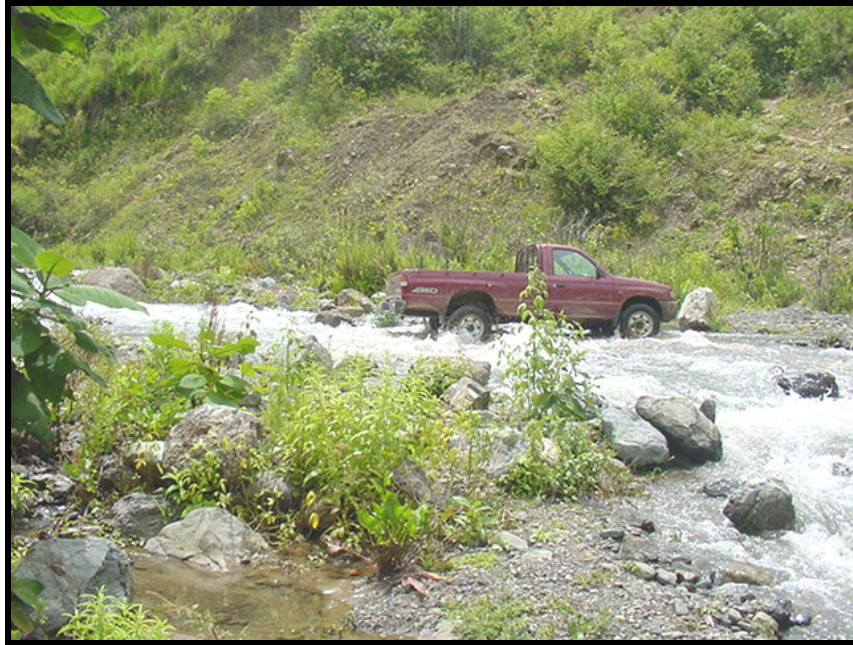
Picture No. 43

Ixtupil River (second entrance), it is harder than the first one, because this one is not dredged.
