Recognition of current status on the Access Roads to “El Tesoro” Project Report.

July 22nd, 2002

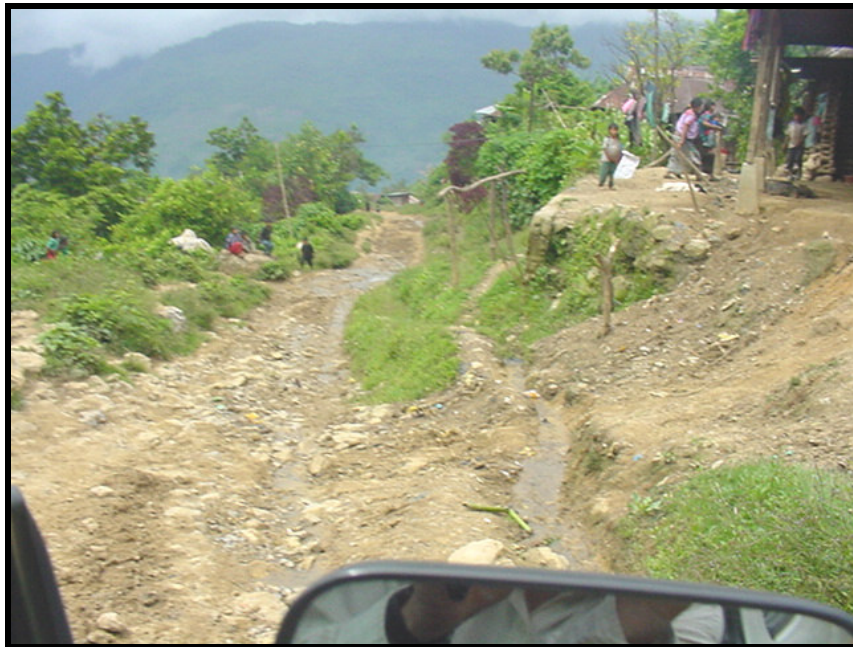
Picture No. 44

The road tread on Ilóm town it is damaged and narrow. It would be necessary to find a new section in order to avoid enter Ilóm.

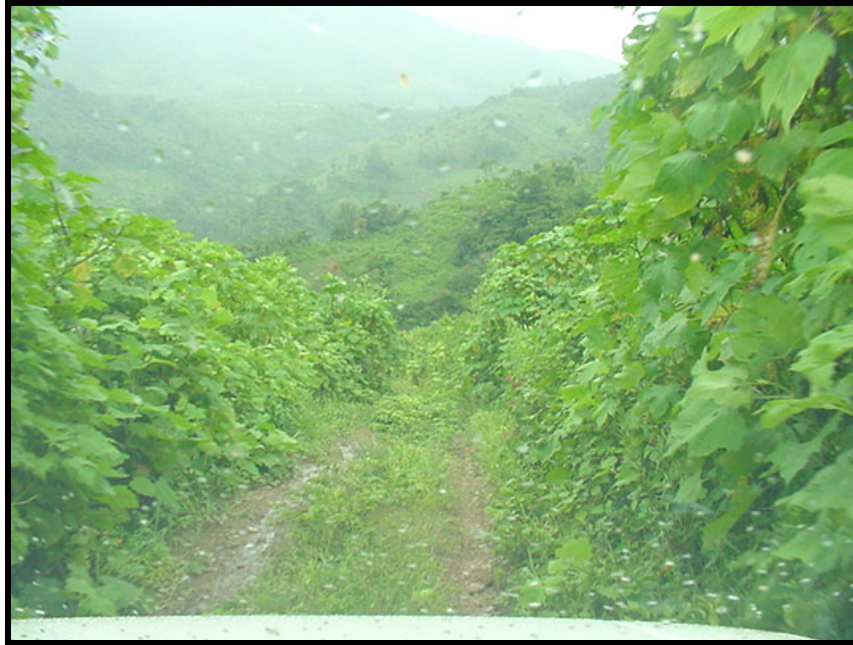
Picture No. 45

Near the high pressure penstock site the soil is argillaceous and that makes pretty difficult to drive through it especially on rainy season. A solution would be to build ditches to drain the rain.
