### Chronology of Operational Challenges

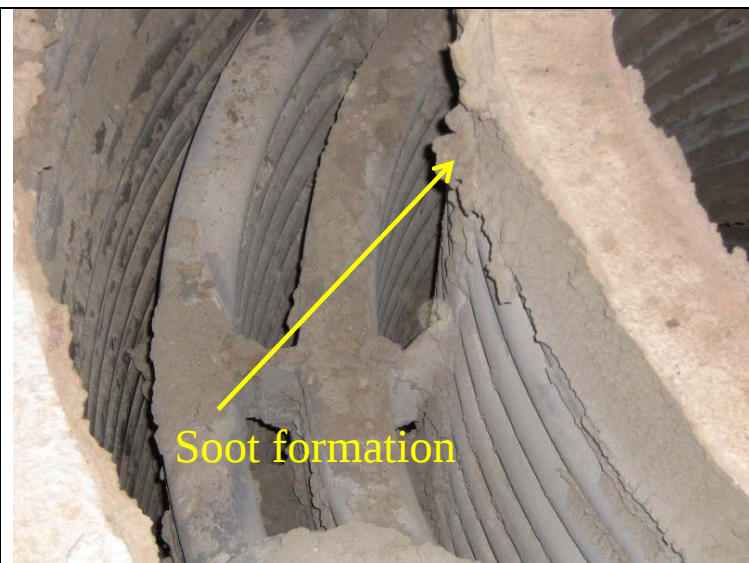
| Item | Challenges | Root Cause | Reference |
|---|---|---|---|
| 1 | <p><u>Furnace no draft</u></p> <ul style="list-style-type: none"> <li>Combustion chamber is kept constantly underpressure to avoid explosion or leakage of flame to outside of the chamber.</li> <li>This underpressure is created by a large suction fan mounted. before the chimney. Between the combustion chamber and suction fan are thermal oil coils and dust collectors where the hot gases produced from the combustion chamber would to pass through.</li> <li>The combustion chamber draft is monitored real time by a pressure sensor. The plant stops whenever combustion chamber's pressure goes to positive (no vacuum).</li> <li>We experienced frequently furnace no draft situation that resulted in stoppage of the plant.</li> </ul> | <p><u>Low ash melting point of EFB fibers</u></p> <ul style="list-style-type: none"> <li>The inherent property of low ash melting point of EFB fibers resulted in formation of 'soft' and 'sticky' ashes.</li> <li>These soft and sticky ashes formed adhere to the thermal oil coils, hot water economisers and dust collector blocking the travel path hot gases.</li> <li>Therefore pressure of the combustion chamber increases.</li> </ul> | <ol style="list-style-type: none"> <li>Faxes from Hartalega to Vyncke, reference <ol style="list-style-type: none"> <li>H.A.-Vync-KML-43</li> <li>H.A.-Vync-KML-44</li> <li>H.A.-Vync-KML-46</li> <li>H.A.-Vync-KML-51</li> </ol> </li> <li>Faxes from Vyncke to Hartalega, reference <ol style="list-style-type: none"> <li>1.2549 dated 20.08.2003</li> <li>1.2549 dated 02.09.2003</li> </ol> </li> <li>Figures 1, 2, 3, and 4</li> </ol> |

Figure 1: Softened ashes sticking to the thermal oil coils

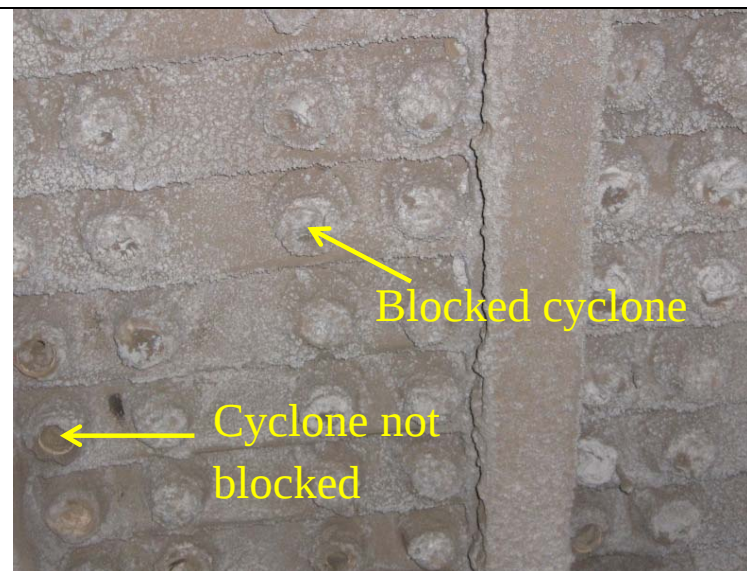
Figure 2: Blocked cyclones in dust collector

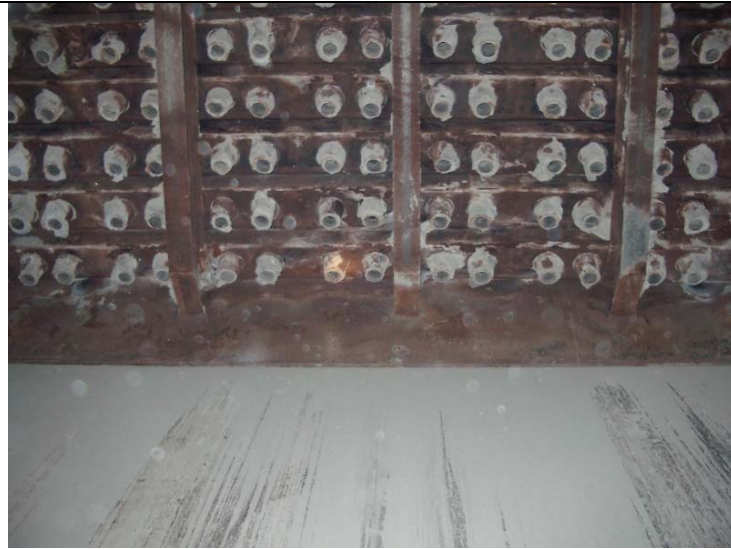
Figure 3: Cyclones cleaned - unblocked

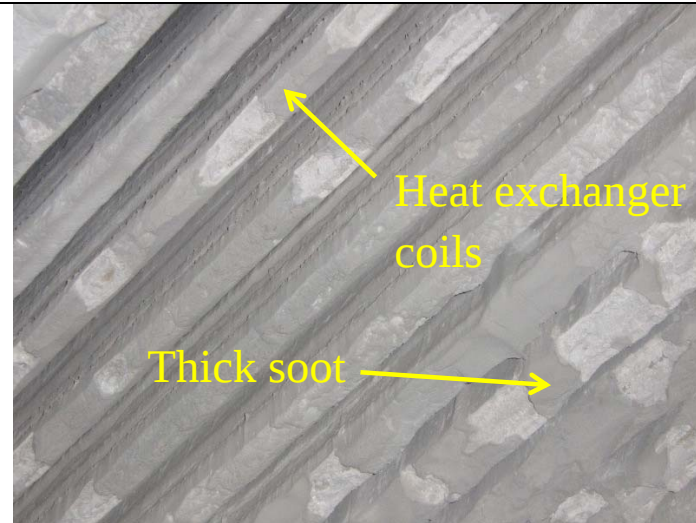
Figure 4: Blocked economiser heat exchanger coils

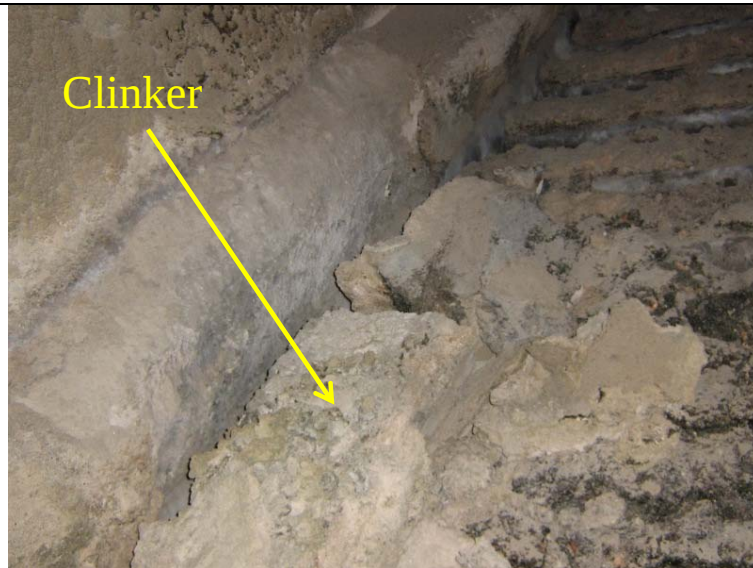
| Item | Challenges | Root Cause | Reference |
|---|---|---|---|
| 2 | <p><u>Excessive clinker formation</u></p> <ul style="list-style-type: none"> <li>Excessive clinkers were formed on the furnace (combustion chamber side wall), furnace floor (step grate) and at the furnace ceiling.</li> </ul> <p><u>Damaged furnace refractory wall</u></p> <ul style="list-style-type: none"> <li>Accumulation of clinker resulted in</li> </ul> | <p><u>Low ash melting point of EFB fibers</u></p> <ul style="list-style-type: none"> <li>A softened / melted ash due to the low melting point property of empty fruit bunches and its high potassium content resulted in formation of hard silica like clinker on the mentioned surfaces.</li> </ul> | <ol style="list-style-type: none"> <li>Faxes from Hartalega to Vyncke, reference <ol style="list-style-type: none"> <li>H.A.-Vync-KML-43</li> <li>H.A.-Vync-KML-44</li> <li>H.A.-Vync-KML-46</li> <li>H.A.-Vync-KML-49</li> <li>H.A.-Vync-KML-51</li> </ol> </li> </ol> |

Figure 5: Excessive clinker formation on furnace floor (step

grate)

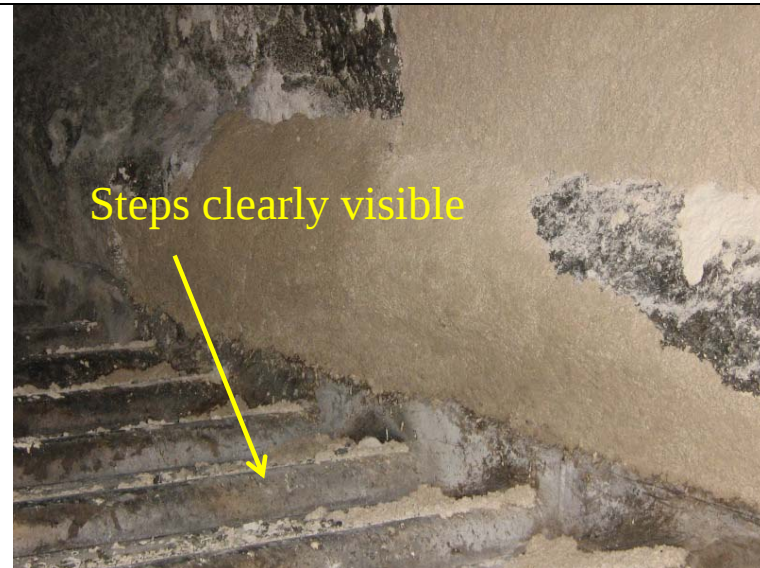
Figure 6: Without clinker, steps of the furnace floor is clearly

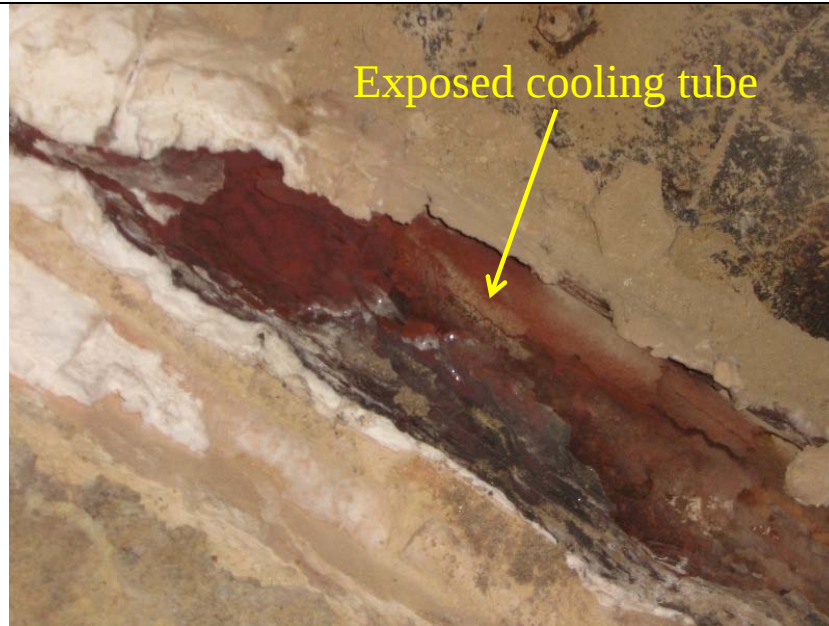
| | collapse of refractory lining of furnace side wall and furnace ceiling. | | <p>2. Fax from Vyncke to Hartalega, reference 1.2549 dated 02.09.2003</p> <p>3. Purchase order no. to replace (overhaul) old refractory with new</p> <ol style="list-style-type: none"> <li>041999</li> <li>040225</li> <li>042141</li> <li>042127</li> <li>042129</li> <li>042473</li> <li>042309</li> </ol> <p>4. Figures 5, 6, 7 and 8</p> |

Figure 7: Damaged refractory at furnace ceiling, exposing cooling pipe. Exposed pipes experience high corrosion

visible

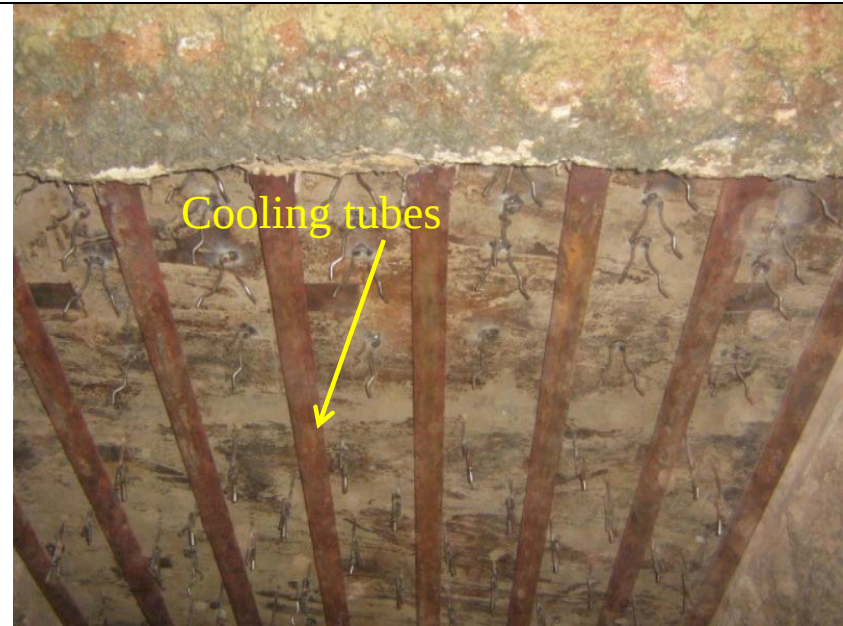
Figure 8: Repair underway for damaged furnace ceiling. Water cooled coils are exposed when refractory is damaged causing excessive corrosion of water coils to take place

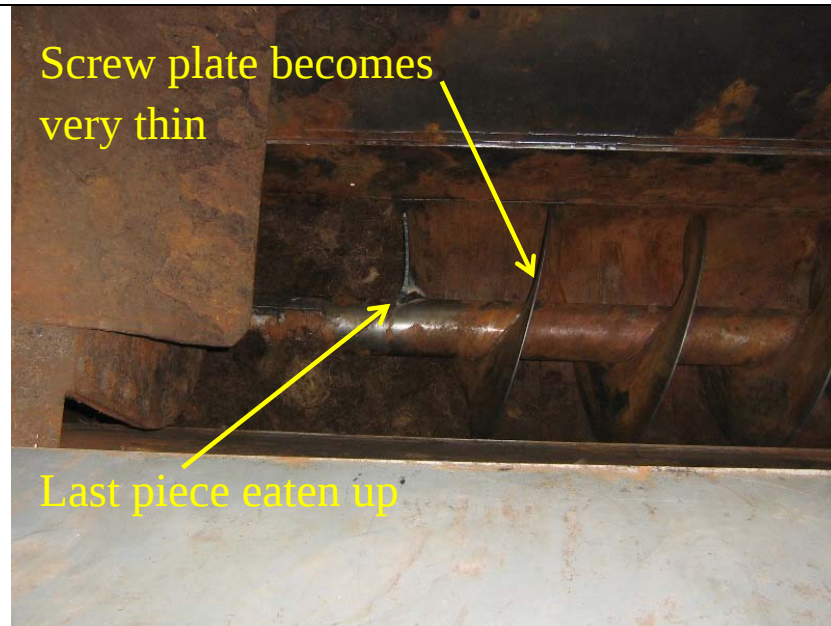
| | <p>a relatively new biomass fuel, therefore its properties are not well established.</p> <ul style="list-style-type: none"> <li>The density of EFB fibers were wrongly estimated by Vyncke, resulting in undersizing of the feeding systems</li> <li>Therefore feeding conveyors speeds were increased to accommodate the undersize condition, resulting in much higher wear and tear.</li> </ul> | <p>density of 250 kg/m<sup>3</sup></p> <ul style="list-style-type: none"> <li>Actual density was found to be around 105 kg/m<sup>3</sup></li> </ul> | <ul style="list-style-type: none"> <li>a. H.A.-Vync-KML-46</li> <li>b. H.A.-Vync-KML-49</li> </ul> <p>2. Faxes from Vyncke to Hartalega, reference</p> <ul style="list-style-type: none"> <li>a. 1.2549 dated 20.08.2003</li> <li>b. 1.2549 dated 02.09.2003</li> <li>c. 1.2549 dated 09.09.2003</li> </ul> <p>3. Figures 9, 10, 11, and 12</p> |

Figure 9: Feeding becomes thin due to excessive wear and tear. Last piece of screw totally eaten up.

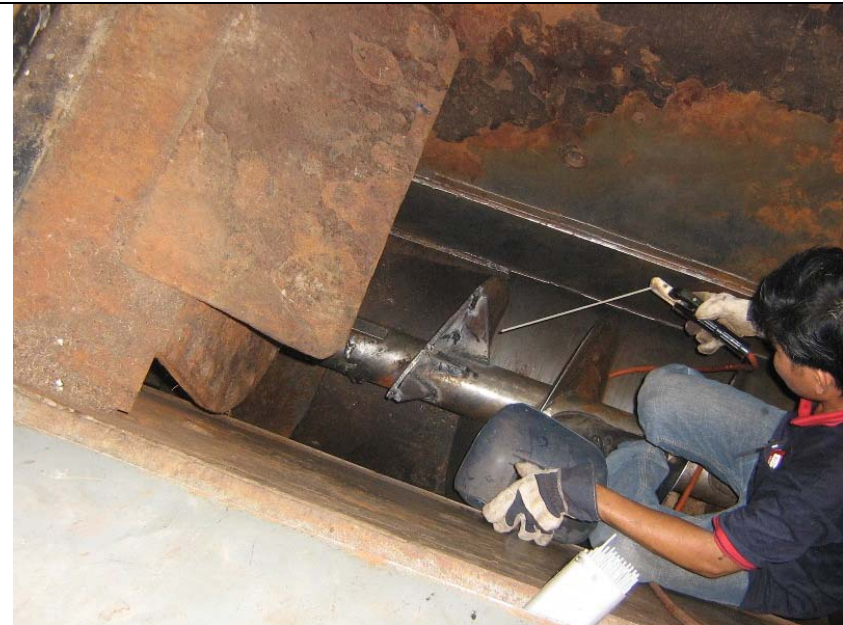
Figure 10: Repair of one of the components of feeding system (screw conveyor)

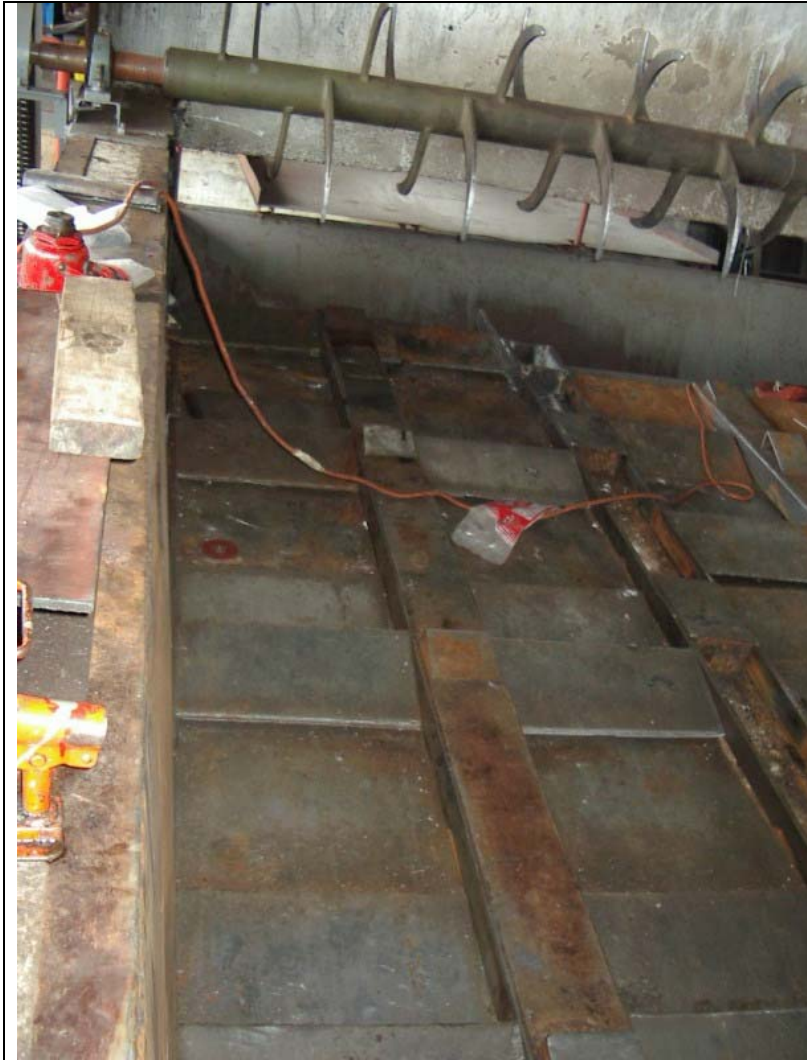
| 5 | <p><u>Damaged moving floor (ESB)</u></p> <ul style="list-style-type: none"> <li>Moving floor is a fuel feeding system that installed at floor level.</li> <li>This system consists of 3 to 4 ladders, each ladder moving back and forth in a horizontal direction parallel to the floor</li> <li>Its function is to discharge biomass materials into feeding screws to convey fuel to the combustion chamber.</li> <li>Moving floor (ESB) for EFB fibers encountered extremely high wear and tear and was also unable to function well</li> <li>A new moving floor was purchased after only running the plant for 18 months</li> </ul> | <p><u>Abrasive property of EFB fibers</u></p> <ul style="list-style-type: none"> <li>Owing to the highly abrasive property of the EFB fibers, the welding joints of the moving floor that were in direct contact with the EFB fibers were ‘grinded’ of, resulting in breakages.</li> </ul> <p><u>Entanglement of EFB fibers</u></p> <ul style="list-style-type: none"> <li>EFB fibers tend to entangle, making this material difficult to convey by the moving floor.</li> <li>Some modifications were carried out but were unsuccessful, instead lead to further damages to the moving floor.</li> </ul> | <p>1. Faxes from Hartalega to Vyncke, referece</p> <ul style="list-style-type: none"> <li>a. H.A.-Vync-KML-49</li> <li>b. H.A.-Vync-KML-51</li> </ul> <p>2. Faxes from Vyncke to Hartalega, referece</p> <ul style="list-style-type: none"> <li>a. 1.2549 dated 09.09.2003</li> <li>b. 1.2549 dated 13.10.2003</li> </ul> <p>3. Figures 11 and 12</p> <p>4. Purchase order no. 037770 to purchase new moving floor</p> |

Figure 11: Moving floor damaged due to wrong design and excessive wear and tear – repair works being carried out

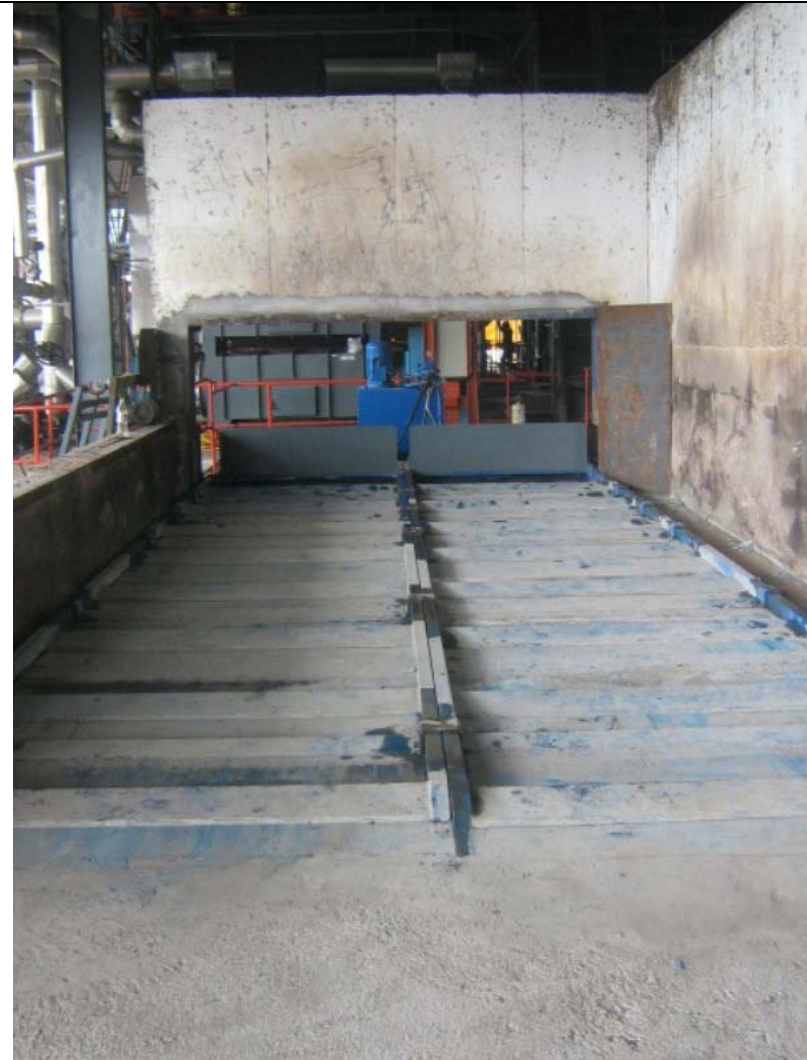
Figure 12: Replacement of new moving due to old one worn out beyond repair

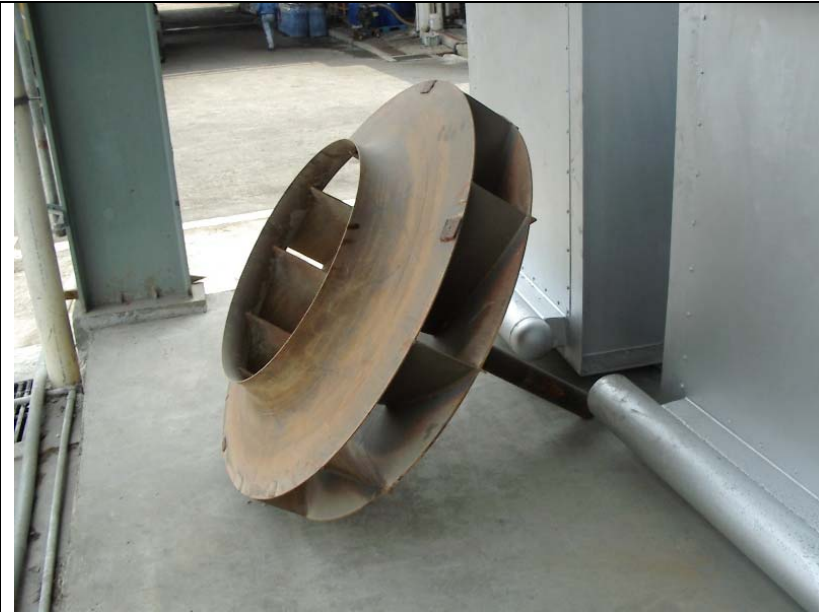
| 7 | <p><u>Damaged impeller of flue gas fan</u></p> <ul style="list-style-type: none"> <li>Flue gas fan impeller welding joints cracked</li> <li>Flue gas fan impellers were noticeably thinner within less than 12 months in operations</li> </ul> | <p><u>Impermeability of EFB fibers</u></p> <ul style="list-style-type: none"> <li>Due to impermeability of the EFB fibers, primary and secondary air flows were increased to provide more air for combustion.</li> <li>Increase in primary and secondary air flows have to be compensated by increasing the speed of the flue gas fan (suction fan installed before the chimney) to maintain a negative pressure inside the combustion chamber.</li> </ul> <p><u>Highly abrasive property of EFB fibers</u></p> <ul style="list-style-type: none"> <li>Due to high ash and potassium content of EFB fibers, the flue gas fan impeller where the air flow</li> </ul> | <p>1. Fax from Hartalega to Vyncke, referece H.A.-Vync-KML-60</p> <p>2. Figures 13 and 14</p> <p>3. Purchase order no. for purchase of new flue gas fan impeller</p> <ol style="list-style-type: none"> <li>031117</li> <li>040699</li> <li>041781</li> </ol> |

| | | <p>speed is the highest experienced high wear and tear</p> <p><u>High operating temperature</u></p> <ul style="list-style-type: none"> <li>• Due to the plant being undersized because of unanticipated problems associated with EFB fibers as biomass fuel, the thermal oil heaters were forced to run at higher temperature in order to achieve its design capacity.</li> <li>• This has resulted in accelerated deterioration of parts</li> </ul> | |

Figure 13: Damaged impeller of flue gas fan

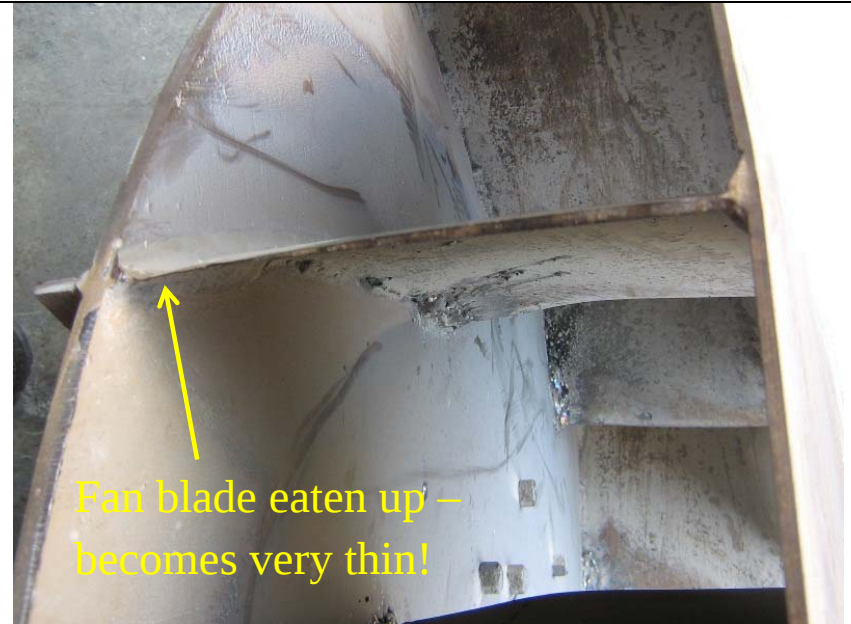
Fan blade eaten up –  
becomes very thin!

Figure 14: Impeller becomes paper thin due to excessive wear and tear

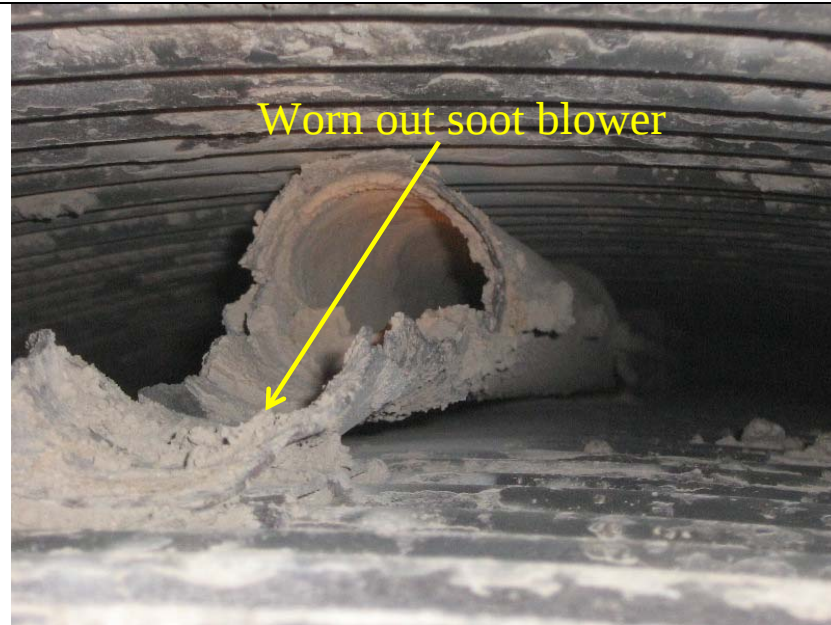
| 9 | <p><u>Damaged Soot Blowers</u></p> <ul style="list-style-type: none"> <li>• Soot blowers are installed to use compress air to blow away soot formed on the outer surface of the thermal oil coils.</li> <li>• These soot blowers experienced high wear and tear</li> </ul> | <p><u>Abrasive nature of EFB fibers</u></p> <ul style="list-style-type: none"> <li>• Owing to the abrasive nature of EFB fiber and its high ash content, the soot blowers have higher wear and tear rate.</li> </ul> | 1. Figures 15 and 16 |

Figure 15: Damaged soot blower

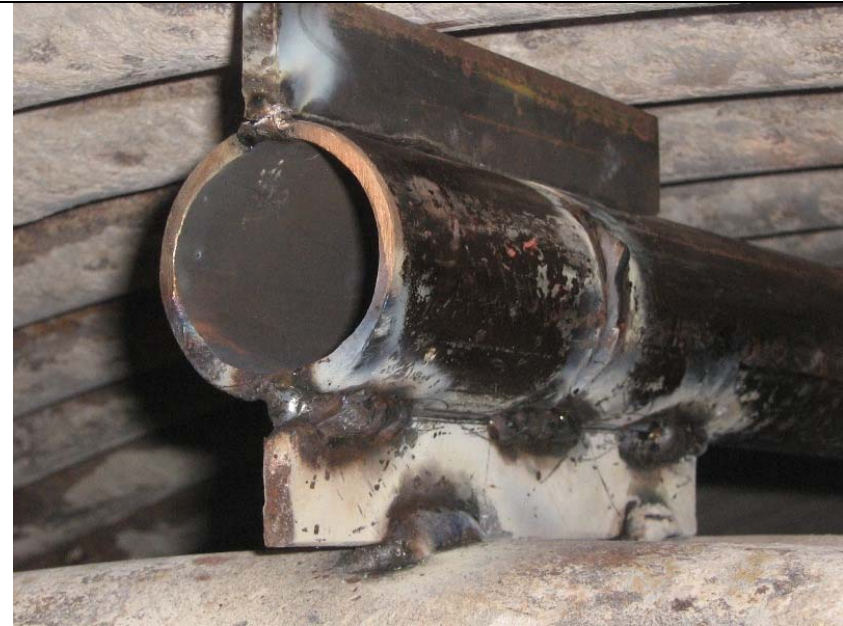
Figure 16: Soot blower repaired
