## Nitrate Stress Corrosion Cracking in Waste Heat Recovery Boilers

R.G.I. Leferink, W.M.M. Huijbregts. C

Anti-Corrosion Methods and Materials, Vol 49 (2002), No 2, p 118-126

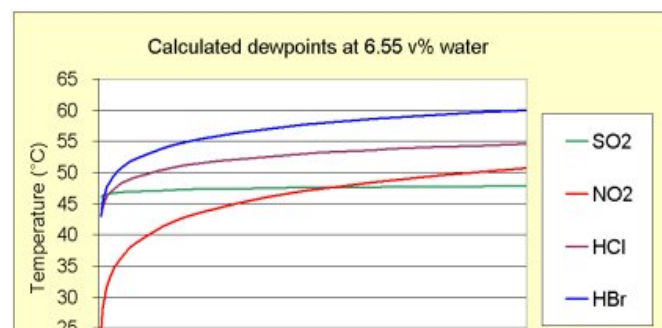
Figure 1 Dewpoint of HCl, HBr, SO<sub>2</sub> and NO<sub>2</sub> containing gasses with 6.55 % water content.

If only water vapour and carbon dioxide were present in the flue gas condensation would only occur at the water dew point. Even when gases such as nitric oxides (NO<sub>x</sub>) and hydrochloric acid (HCl) are present, condensation still will occur at temperatures very close to the water dew point. However, the presence of sulphur trioxide (SO<sub>3</sub>) has a major impact on the dew point of the flue gas. Based on data from literature, (Yen Hsiung Kiang, 1981; Land, 1977, KEMA report, 1990), a computer program was written to calculate the dew points and corrosiveness of various gas compositions. Figures 1 and 2 show the huge difference in dew point between the SO<sub>3</sub> gas and the other gases.

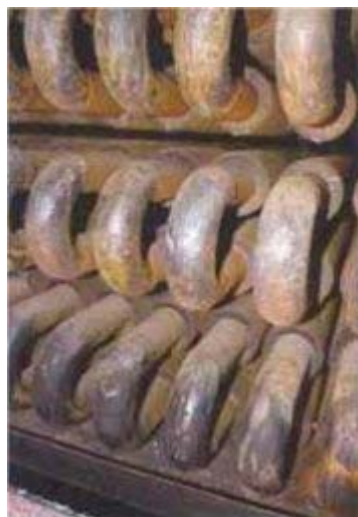
Figure 3

Finned boiler tubes with nitrate induced SA-IGA in the bends. Finned pipes are used to increase the surface area of the heat exchangers.

In the 1990's several failures caused by SCC occurred in the WHRB of combined cycle power plants in the Netherlands (KEMA 2000). The cracks were mostly found in the low temperature heat exchangers. In general, these had been fabricated from steel 35.8, a standard plain carbon steel. Most cracking occurred in bends where mechanical stresses were relatively high. Microscopic analysis of samples revealed that intergranular corrosion had occurred and it was frequently reported that complete grains of material had become detached. See Figures 3 and 4.

Because in a few cases very thick deposits of ammonium nitrate were found near the damaged areas, nitrate SCC was identified as the cause. Initially the affected tubes were replaced with alloy 15Mo3 because it was presumed that this material had a higher resistance to nitrate SCC. This assumption was based on various published papers on the better corrosion resistance of the steel 15Mo3 (Bunning et al 1990, Dahl et al 1987, Drodten et al 1991, Krautschick et al 1988). Heat treatments to reduce stress levels were also tried as a remedy. However the material 15Mo3 later also failed by nitrate SCC. See Table 2.

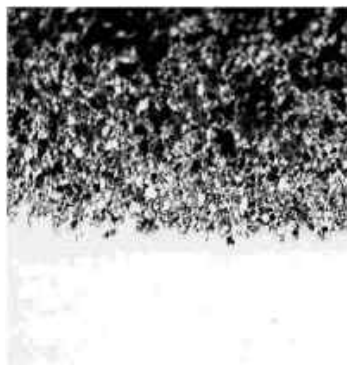
Figure 8.

Detail of the corrosion front in the sample from figure 3b shows the intergranular nature of the attack.

At a potential of +100 mV SHE severe IGA occurred in the steel. Within a period of 16 hours steel was attacked to a depth of 300 µm. (Figures 7 and 8). The observed intergranular corrosion showed a remarkable resemblance to the microstructure found in the failures from recovery boilers.

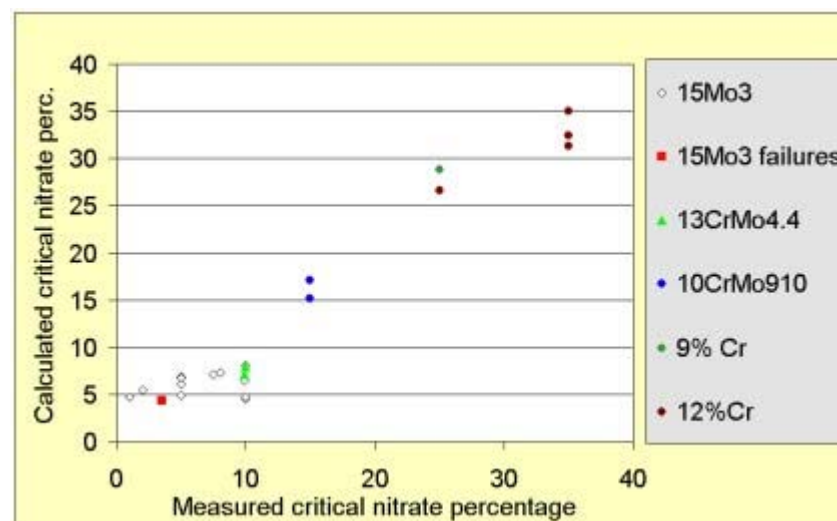
Figure 10. Correlation between measured and calculated critical nitrate concentrations for 15Mo3, 13CrMo4.4, 10CrMo9.10, 9% Cr and 12% Cr steels.

$$\text{Critical nitrate per cent} = 20\text{Mn} + 10\text{Mo} + 2\text{Cr} + 1\text{Si} - 5 - 35\text{C} - 7\text{Cu}$$

The correlation between measured and calculated critical nitrate percentages is given in Figure 10 for the last mentioned group of steels.
